Washington Briefing
Deepwater Horizon Interim Incident Investigation

24th May 2010

Deepwater Horizon Incident Timeline and Animation of Events

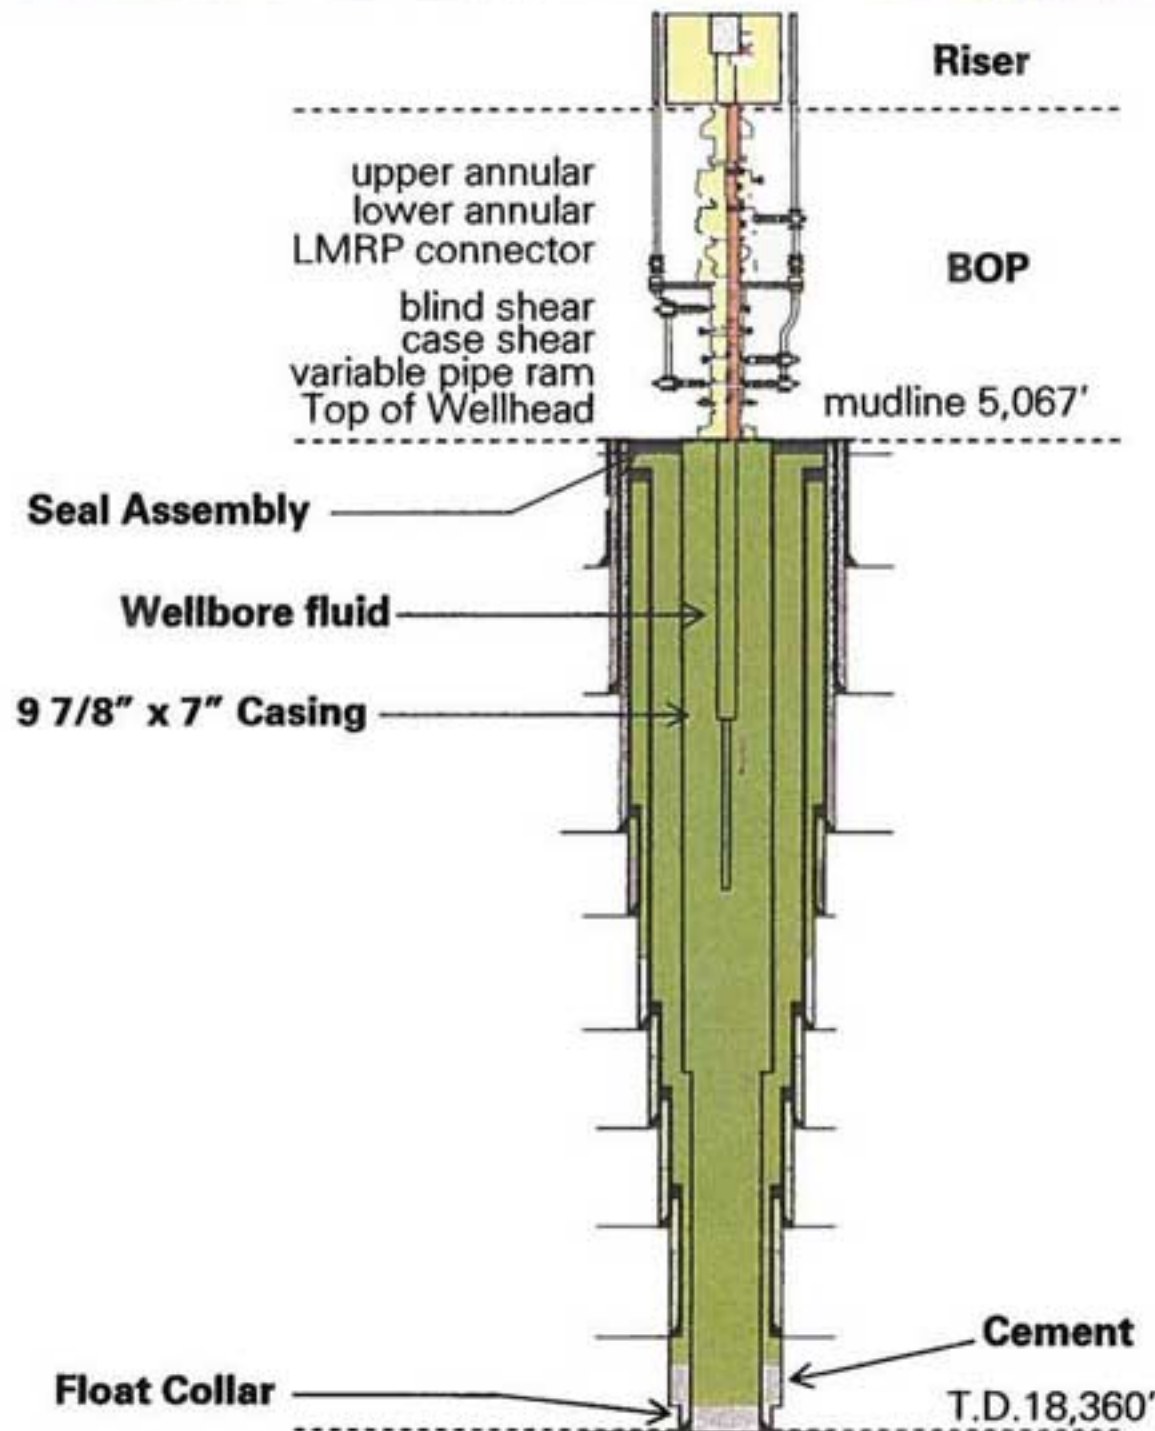
Macondo Well Diagram – Key Components & Critical Factors

1. Loss of Integrity of the 9 7/8" x 7" casing created a path for hydrocarbon (HC) influx
2. Unrecognized well conditions
 - Influx unrecognized - Integrity test failed to identify communication with the reservoir
 - Operations allowed HC influx to enter and move up the well bore – *well became capable of flowing*
 - Response failed to control the well
3. BOP & Emergency Systems failed to isolate the HC source
4. Gas plume ignited

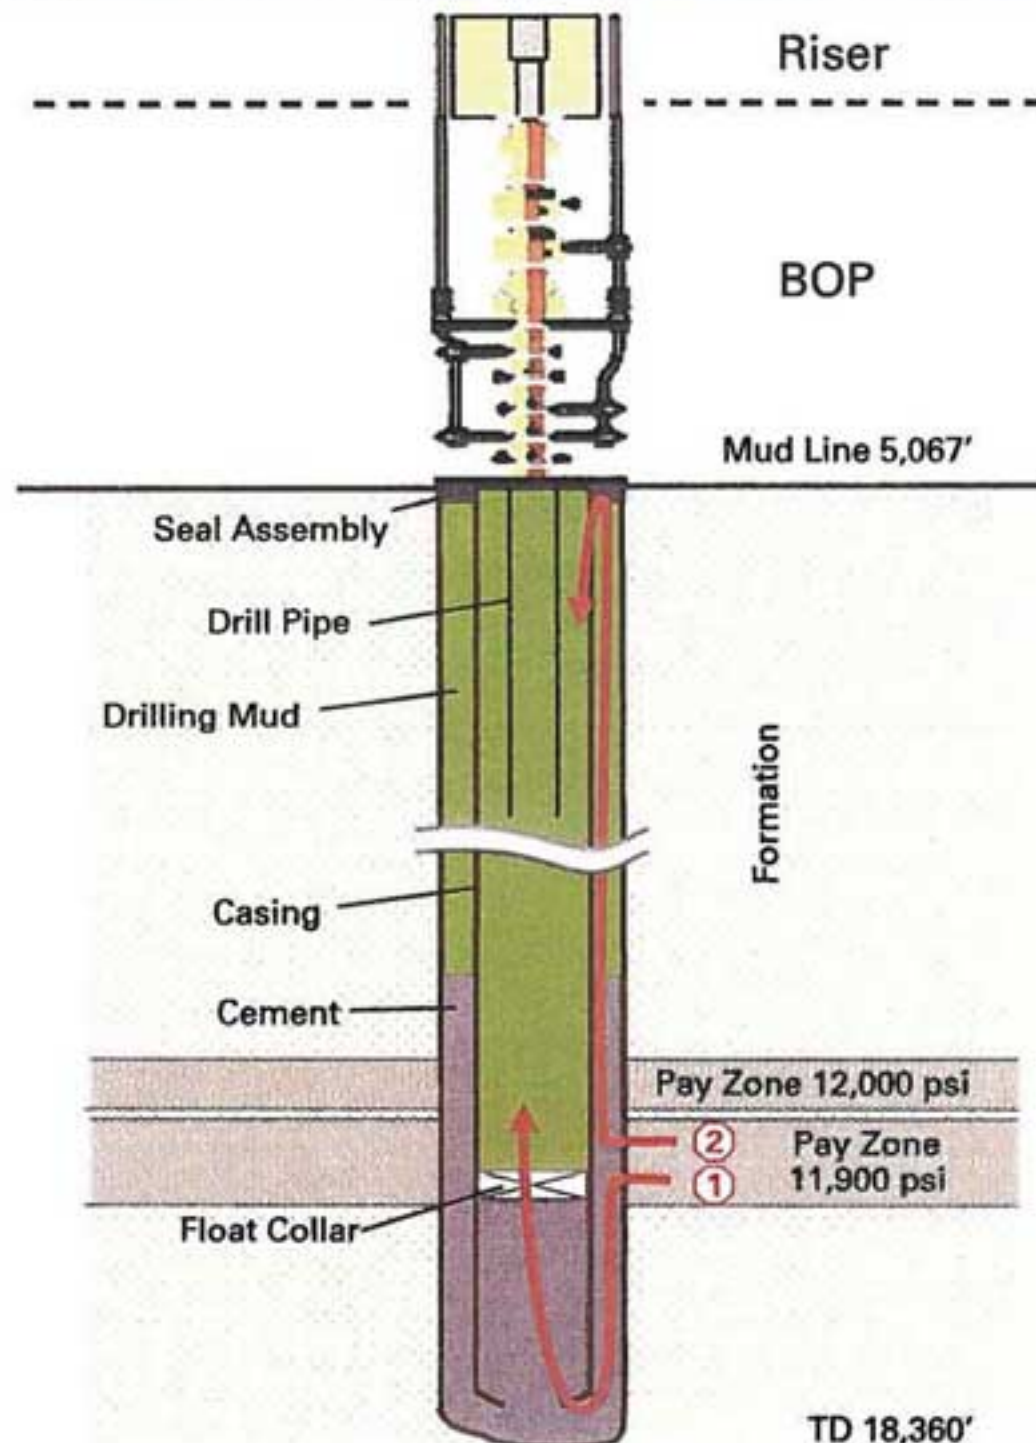
Critical Factor 1 – Loss of Integrity of Casing

Loss of Integrity of 9-7/8" x 7" Casing

- Cement failed to isolate the reservoir
- The float collar (1) or the seal assembly (2) leaked

- Review design and execution of the cement job
- Review design and installation of casing shoe track and seal assembly
- Laboratory testing of float collar
- Detailed well dynamic modeling to assess likely influx point

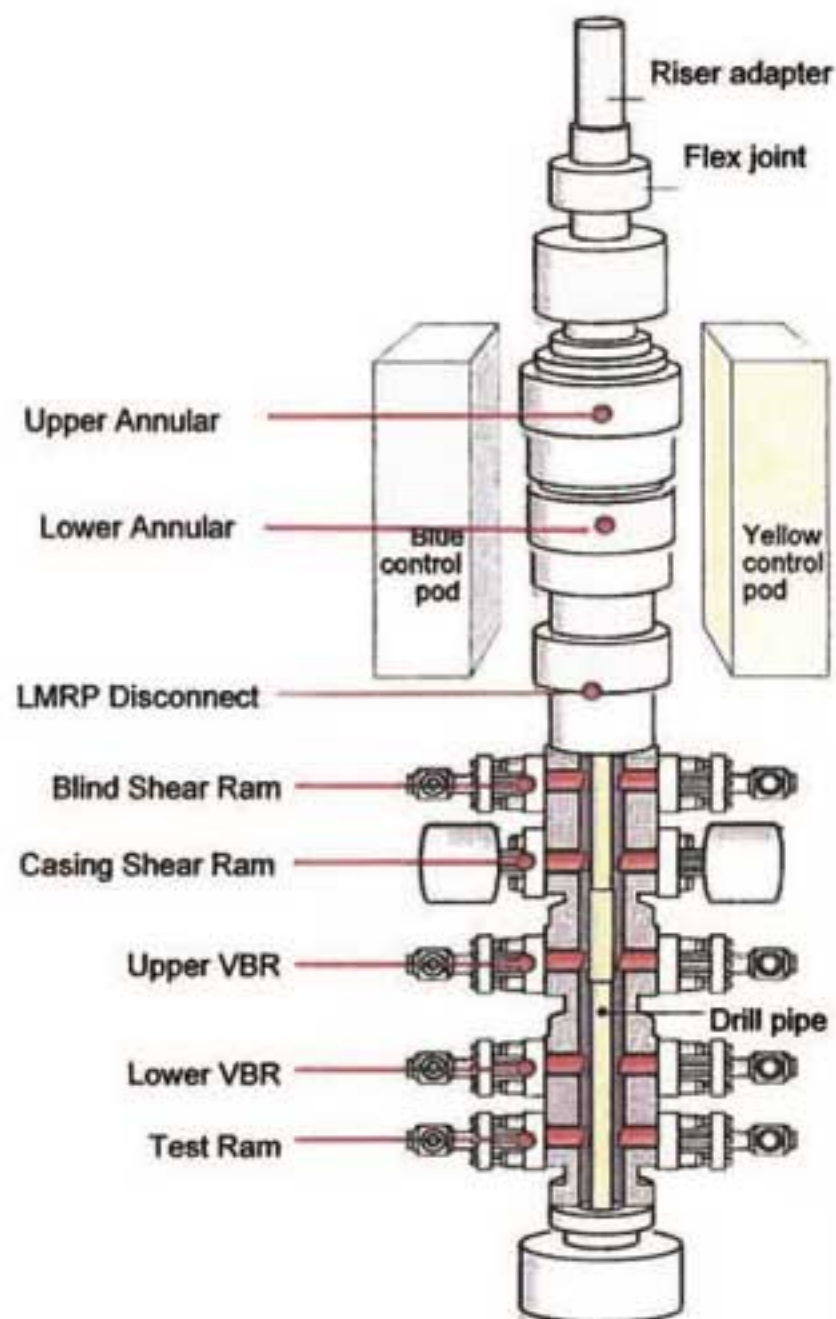
Critical Factor 3 – BOP Failed to Isolate Source

BOP Failed to Isolate Source

- Action to activate the BOP once well condition was recognized failed to isolate the source
- EDS failed to secure the well (when activated from bridge after explosion)
- AMF/Dead-man failed to secure well
- Subsequent ROV interventions failed to secure the well

- Understand BOP testing history and performance of emergency systems, EDS, Auto shear, AMF (Deadman), ROV hot stab
- Understanding of BOP modifications – could they have affected its functionality?
- Assess leaks identified during ROV intervention and determine significance – could they have affected its functionality?
- Evaluation of BOP maintenance history regards system completeness, OEM parts and 3rd party services
- Inspect & test BOP once retrieved from sea floor

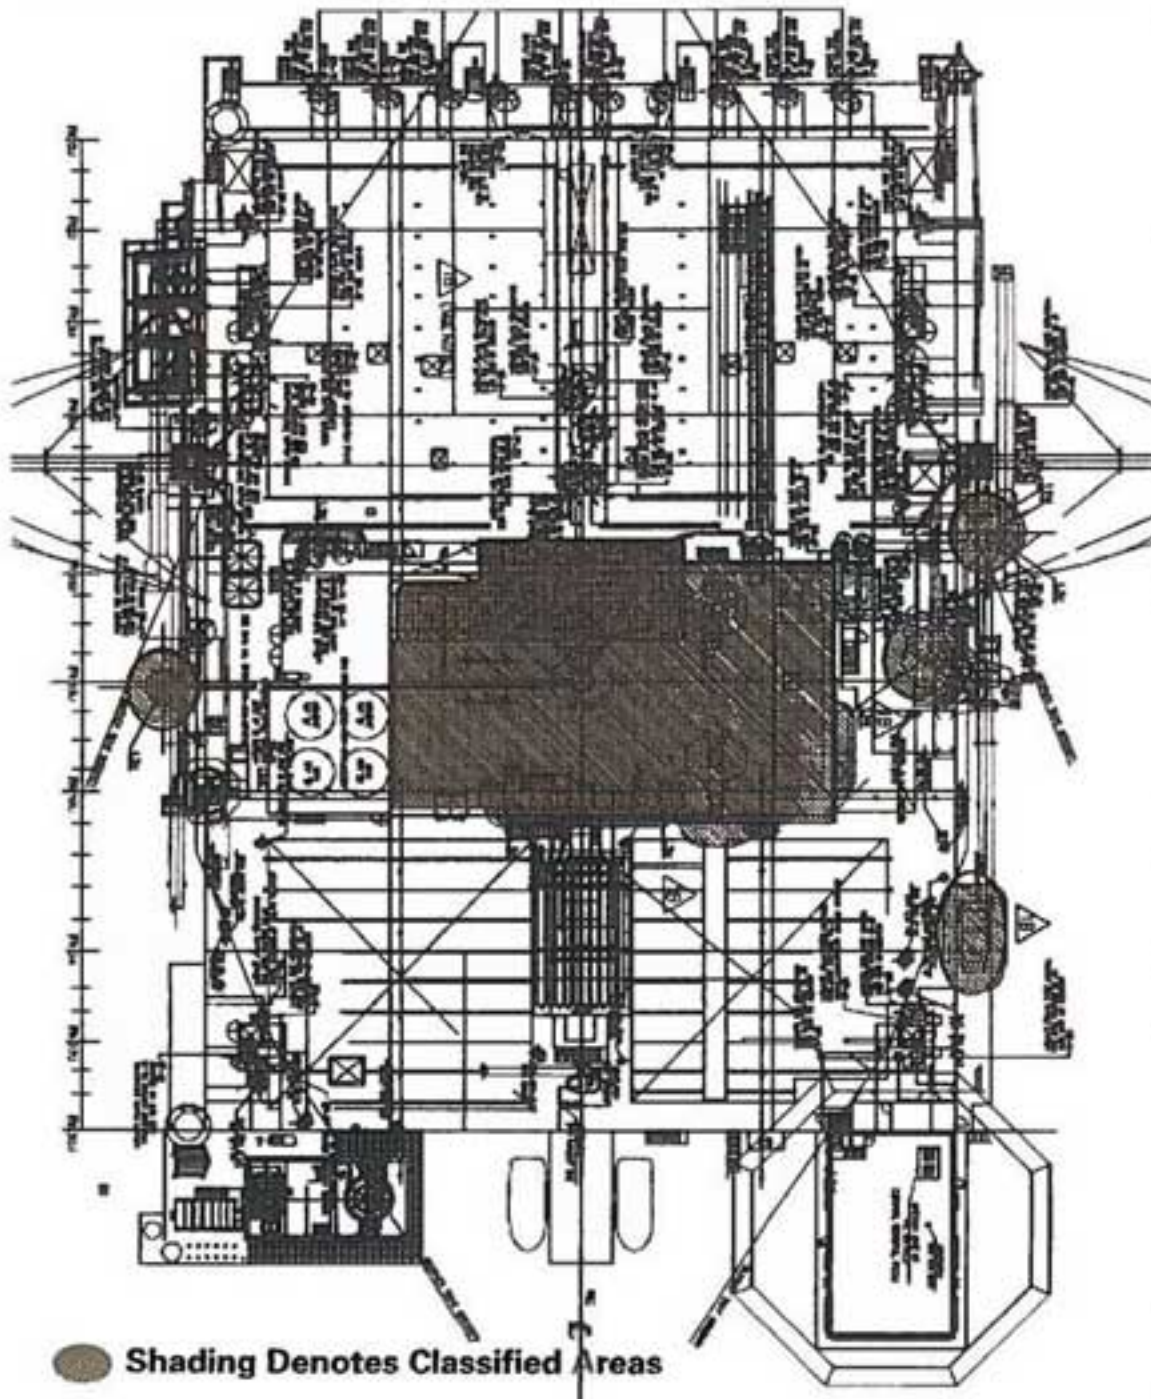
Hazardous Area Classification - Main Deck

Ignition of Released Hydrocarbons

- Hydrocarbon gas detected by several gas detectors prior to explosion (two witness statements from bridge).
- Several potential scenarios of hydrocarbon release to atmosphere have been identified.
- Dynamic modeling estimates suggests that flammable gas mixtures could have reached non-electrically classified areas.

- Fluid dynamic modeling being further developed in-line with most probable release scenarios.
 - Access to pit room / mud pumps
 - Access to derrick via degasser
 - Access to engine room
- Review of electrical area classification, fire and gas design and ventilation system design.

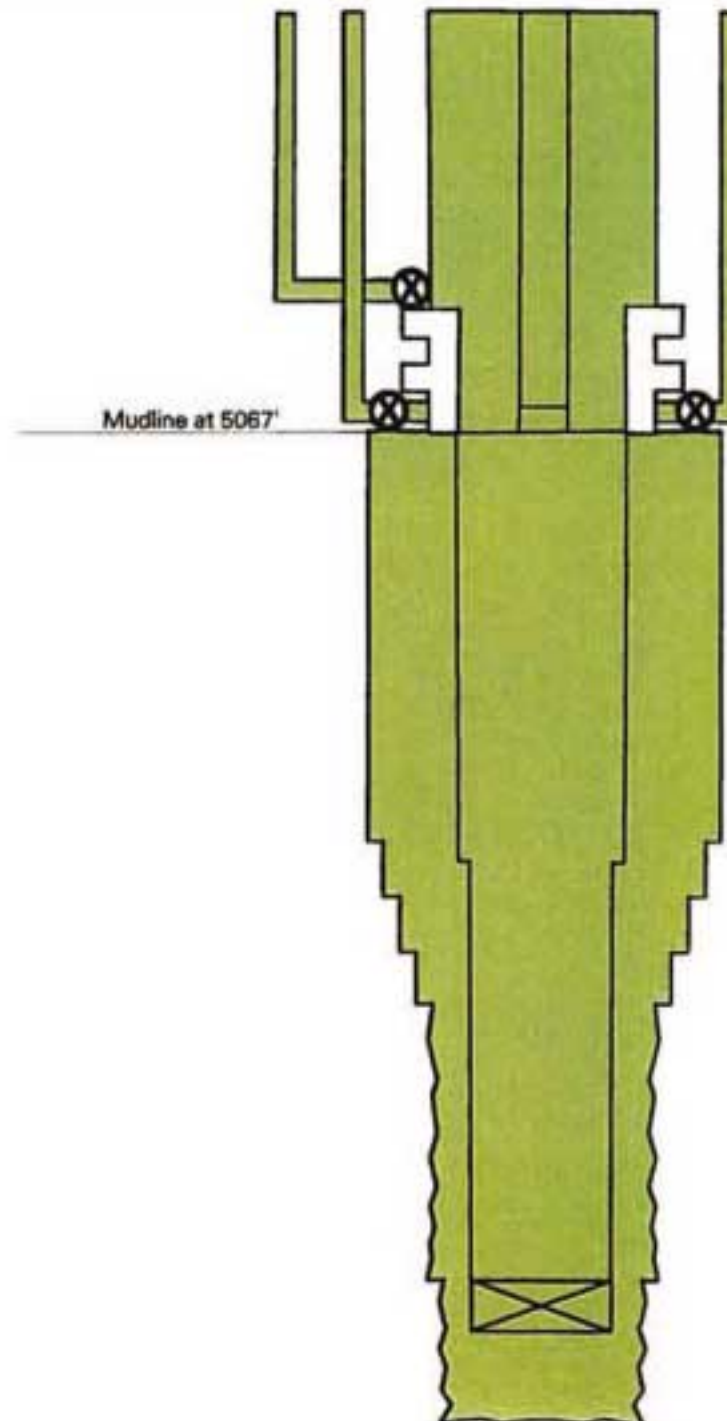
Run Casing – Convert Float Equipment

- Run 7" x 9-7/8' production casing
 - Crossover at 12487'
 - Float Collar at 18114'
 - Shoe at 18304'
 - 56' of rat hole
- Laid out three joints of 7" due to damaged threads
- Saw 10k weight bobble at 18218 (only time string took weight during run)
- 9 attempts to convert float equipment
 - Sheared at 3142 psi vs 500-700 psi design

- Circulating pressure below normal after shearing float collar

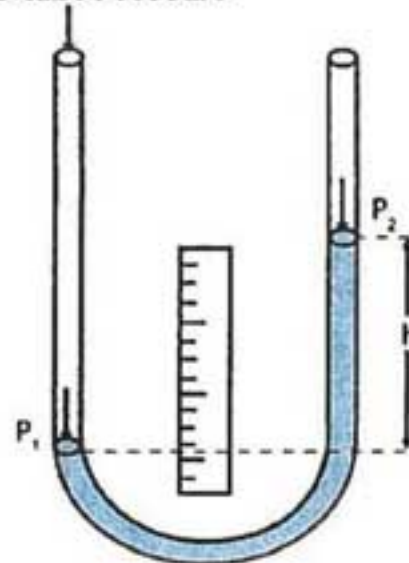
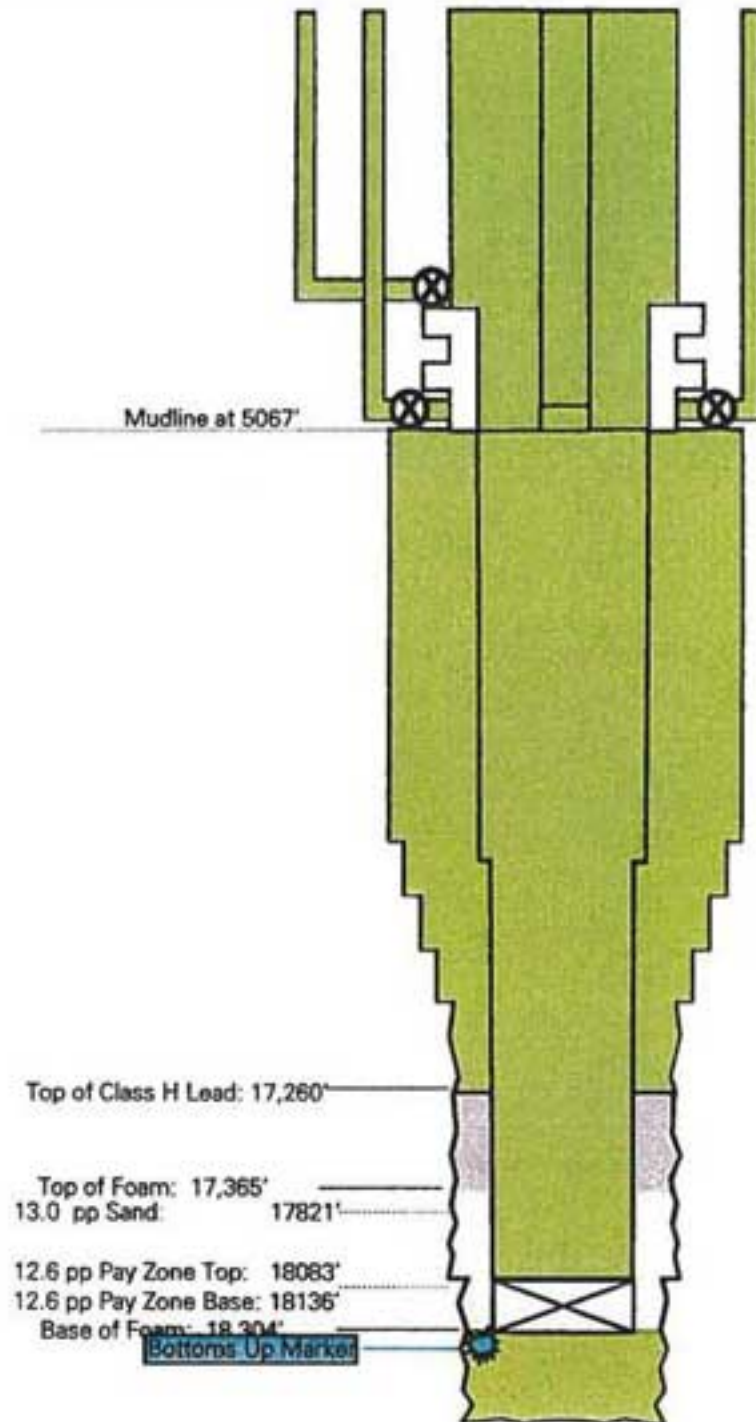
Cement Job

- Circulate 342 bbl before cement job
- Pump nitrified foam cement
 - Pumped 60 bbl cement
- Estimated TOC at 17260'
- Bumped plug with 1150 psi
 - Cement in place at 00:35
 - Bled back 5 bbls to 0 psi
 - Minimal calculated U-tube pressure after job (nearly balanced)
- 14.0 ppg mud in rathole with 16.7 ppg cement in shoe track

- Job pumped per plan – no cement losses observed
- Minimal U-tube may have prevented definitive float test
- Potential for contamination of cement in shoe track due to density difference between cement and mud

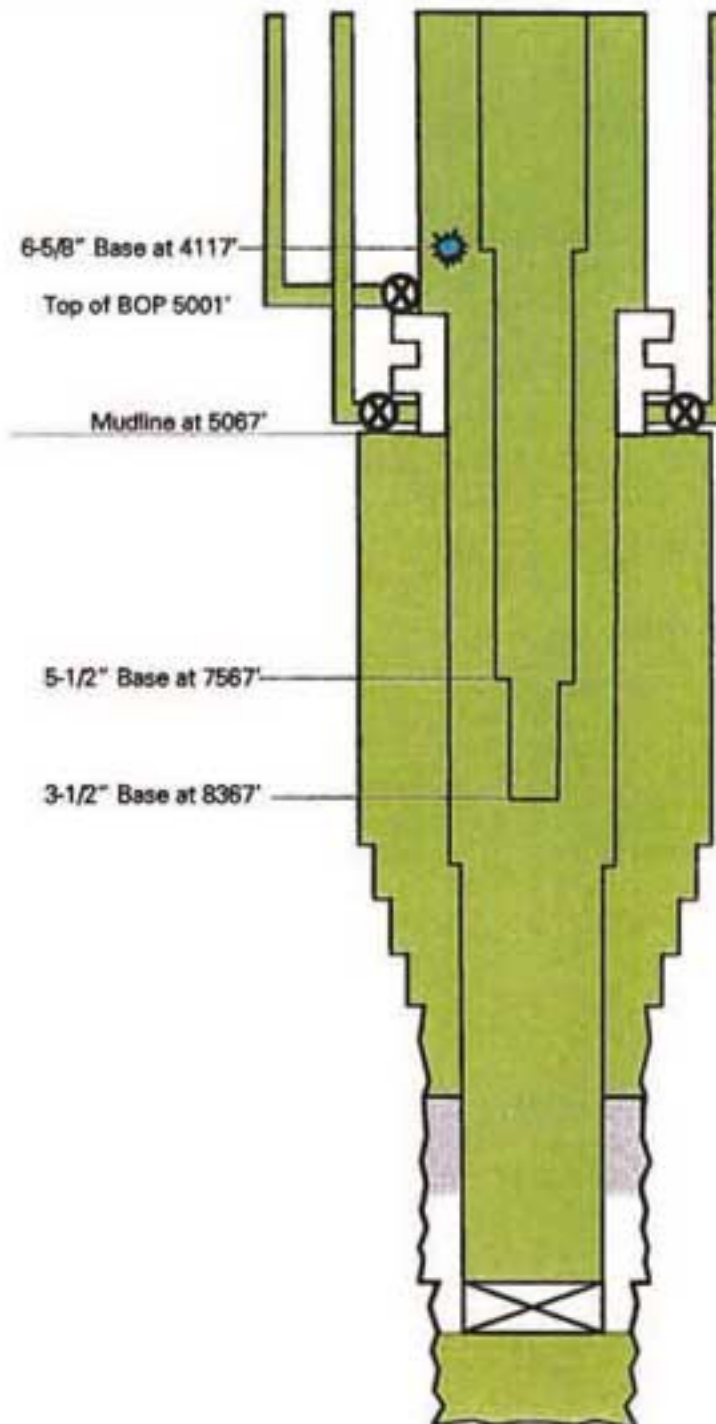
Finish Trip in Hole

- Finish RIH to 8367'
- Mud transfer to boat begins at 13:28

- The approach to transferring mud may have impaired pit monitoring over next 4 hours

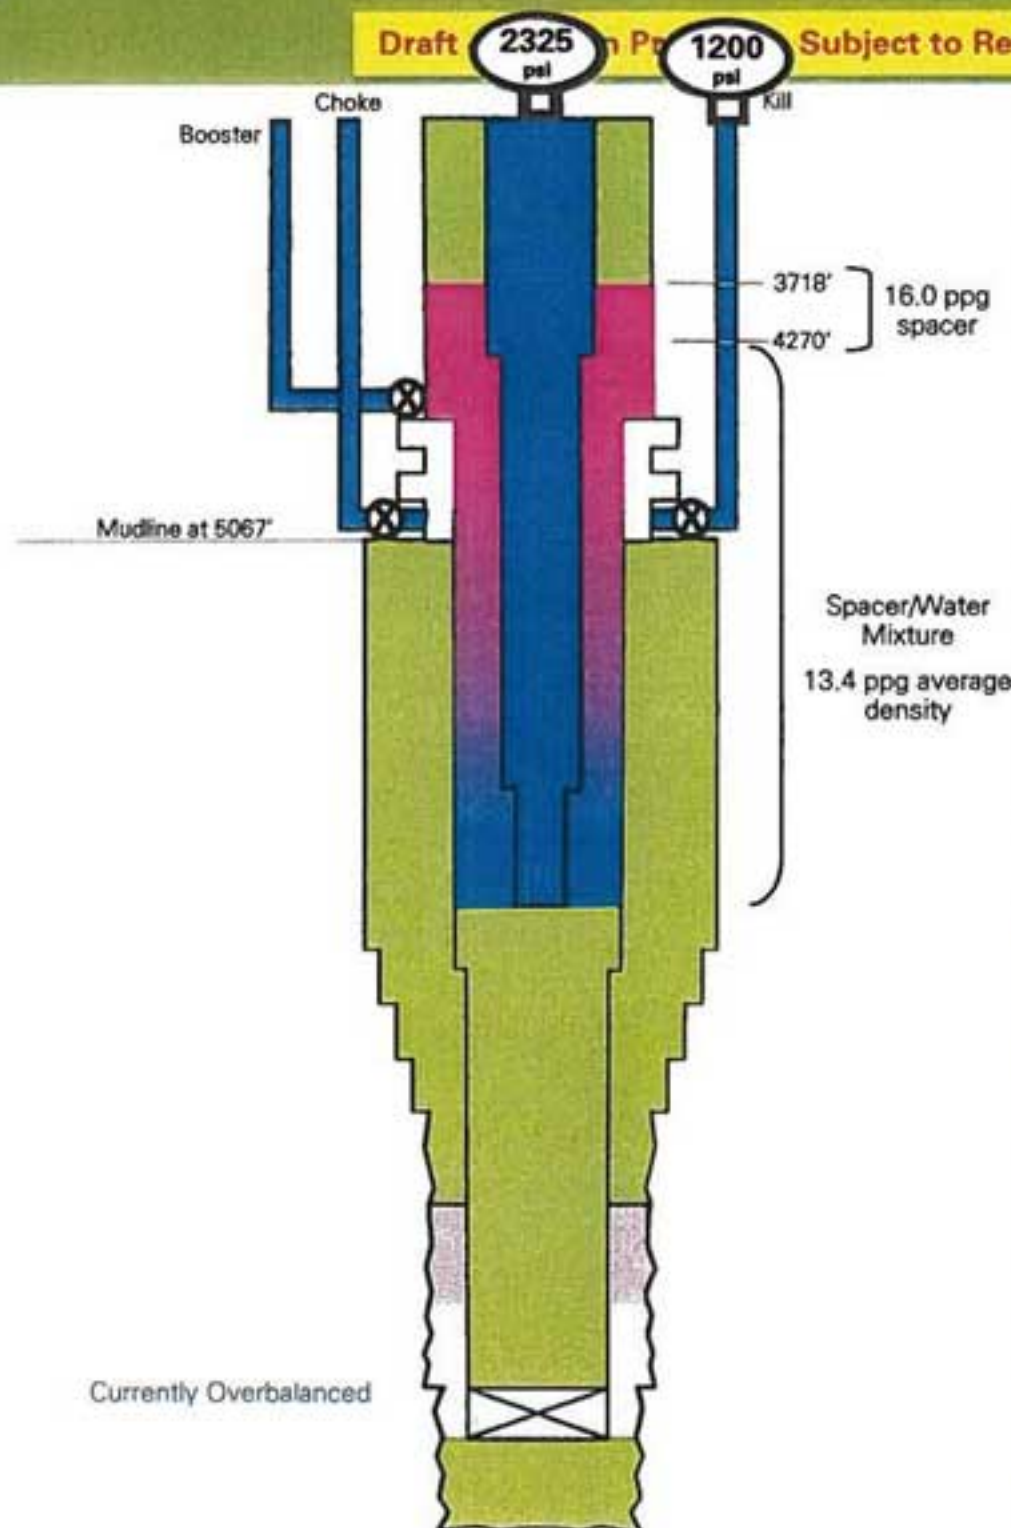
Pump Seawater

- Pump 352bbls seawater
 - Not enough to get spacer above BOP
- 2325 psi static pressure after pumping
 - Calculated U-tube is 1628 psi

- Higher than expected static pressure may indicate large spacer-to-water interface
- Significant solids settling expected once pumps stop
- High gel strength with 100% spacer

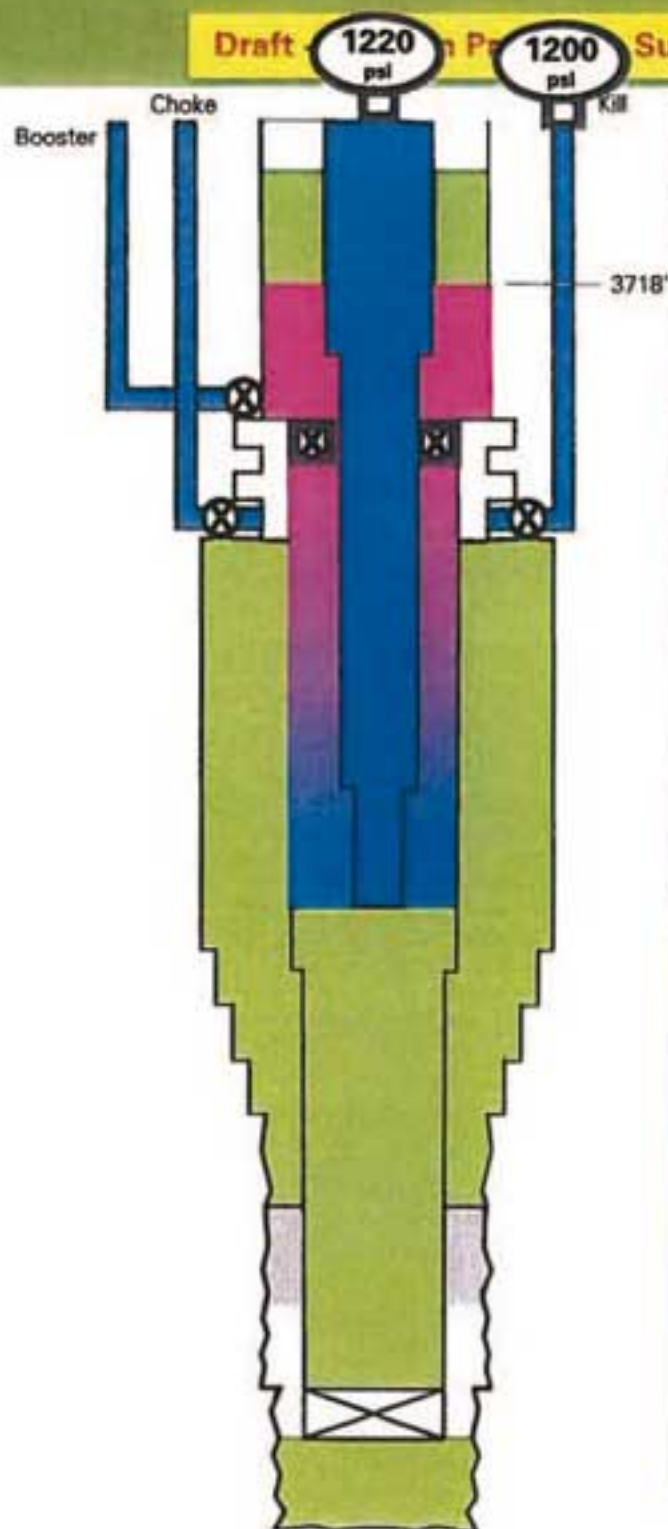
Bleed to 273 psi

- Open kill line
- Pressure equalizes
 - Drillpipe pressure goes to 1400 psi
 - Kill line pressure drops to 645 psi
- Bleed pressure to 273 psi on drillpipe as kill line pressure drops to zero
 - DP pressure never gets to zero
- First time well is under balance
- Observed that fluid level in the riser had dropped

- U-tube between drill pipe and kill line due to heavy fluid in the annulus
- Suspect the annular is leaking

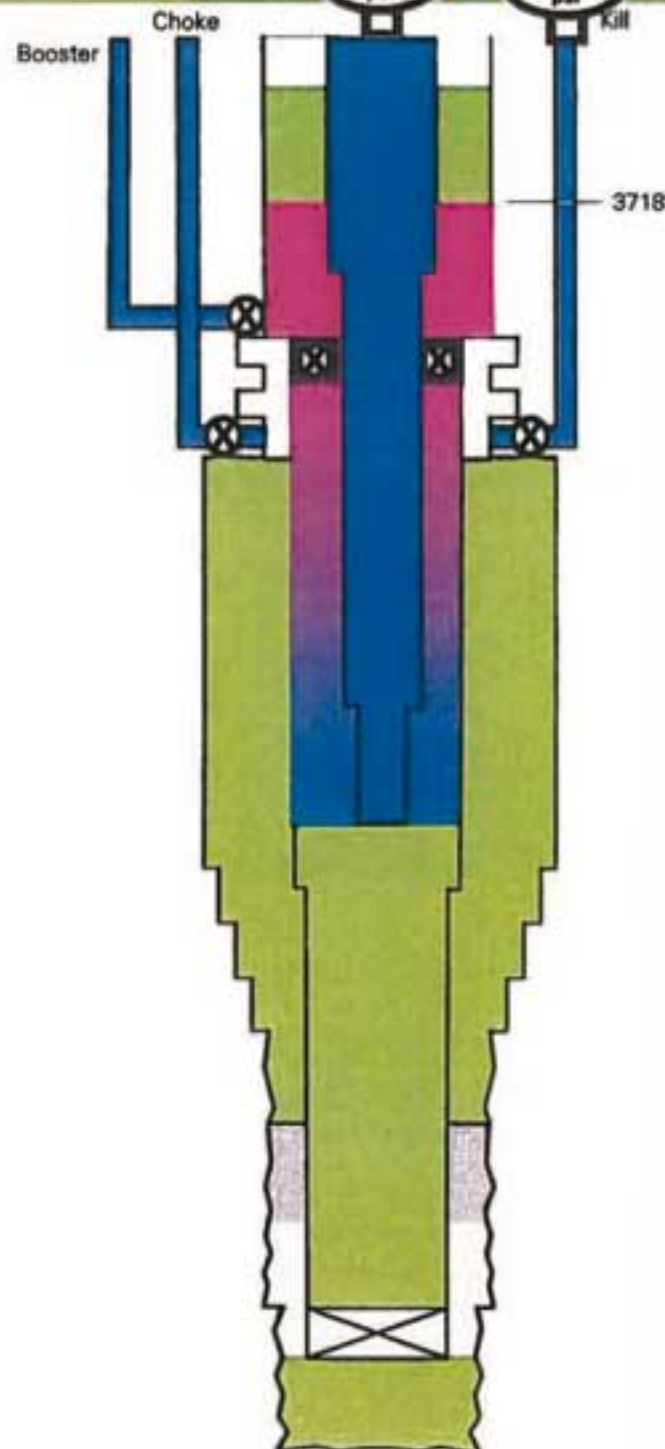
Drillpipe Pressure Builds / Fill Riser

- Shut in drillpipe
- Pressure builds to 1250 psi in 6 minutes
- Filled the riser with 50bbls from trip tank
- Mud offload to Bankston ends at 17:17
 - Mudloggers not informed that offloading had ceased

- If the annular was leaking it is now sealed
- Discussion on rig floor about pressure on drillpipe
 - Decision made to conduct negative test on kill line

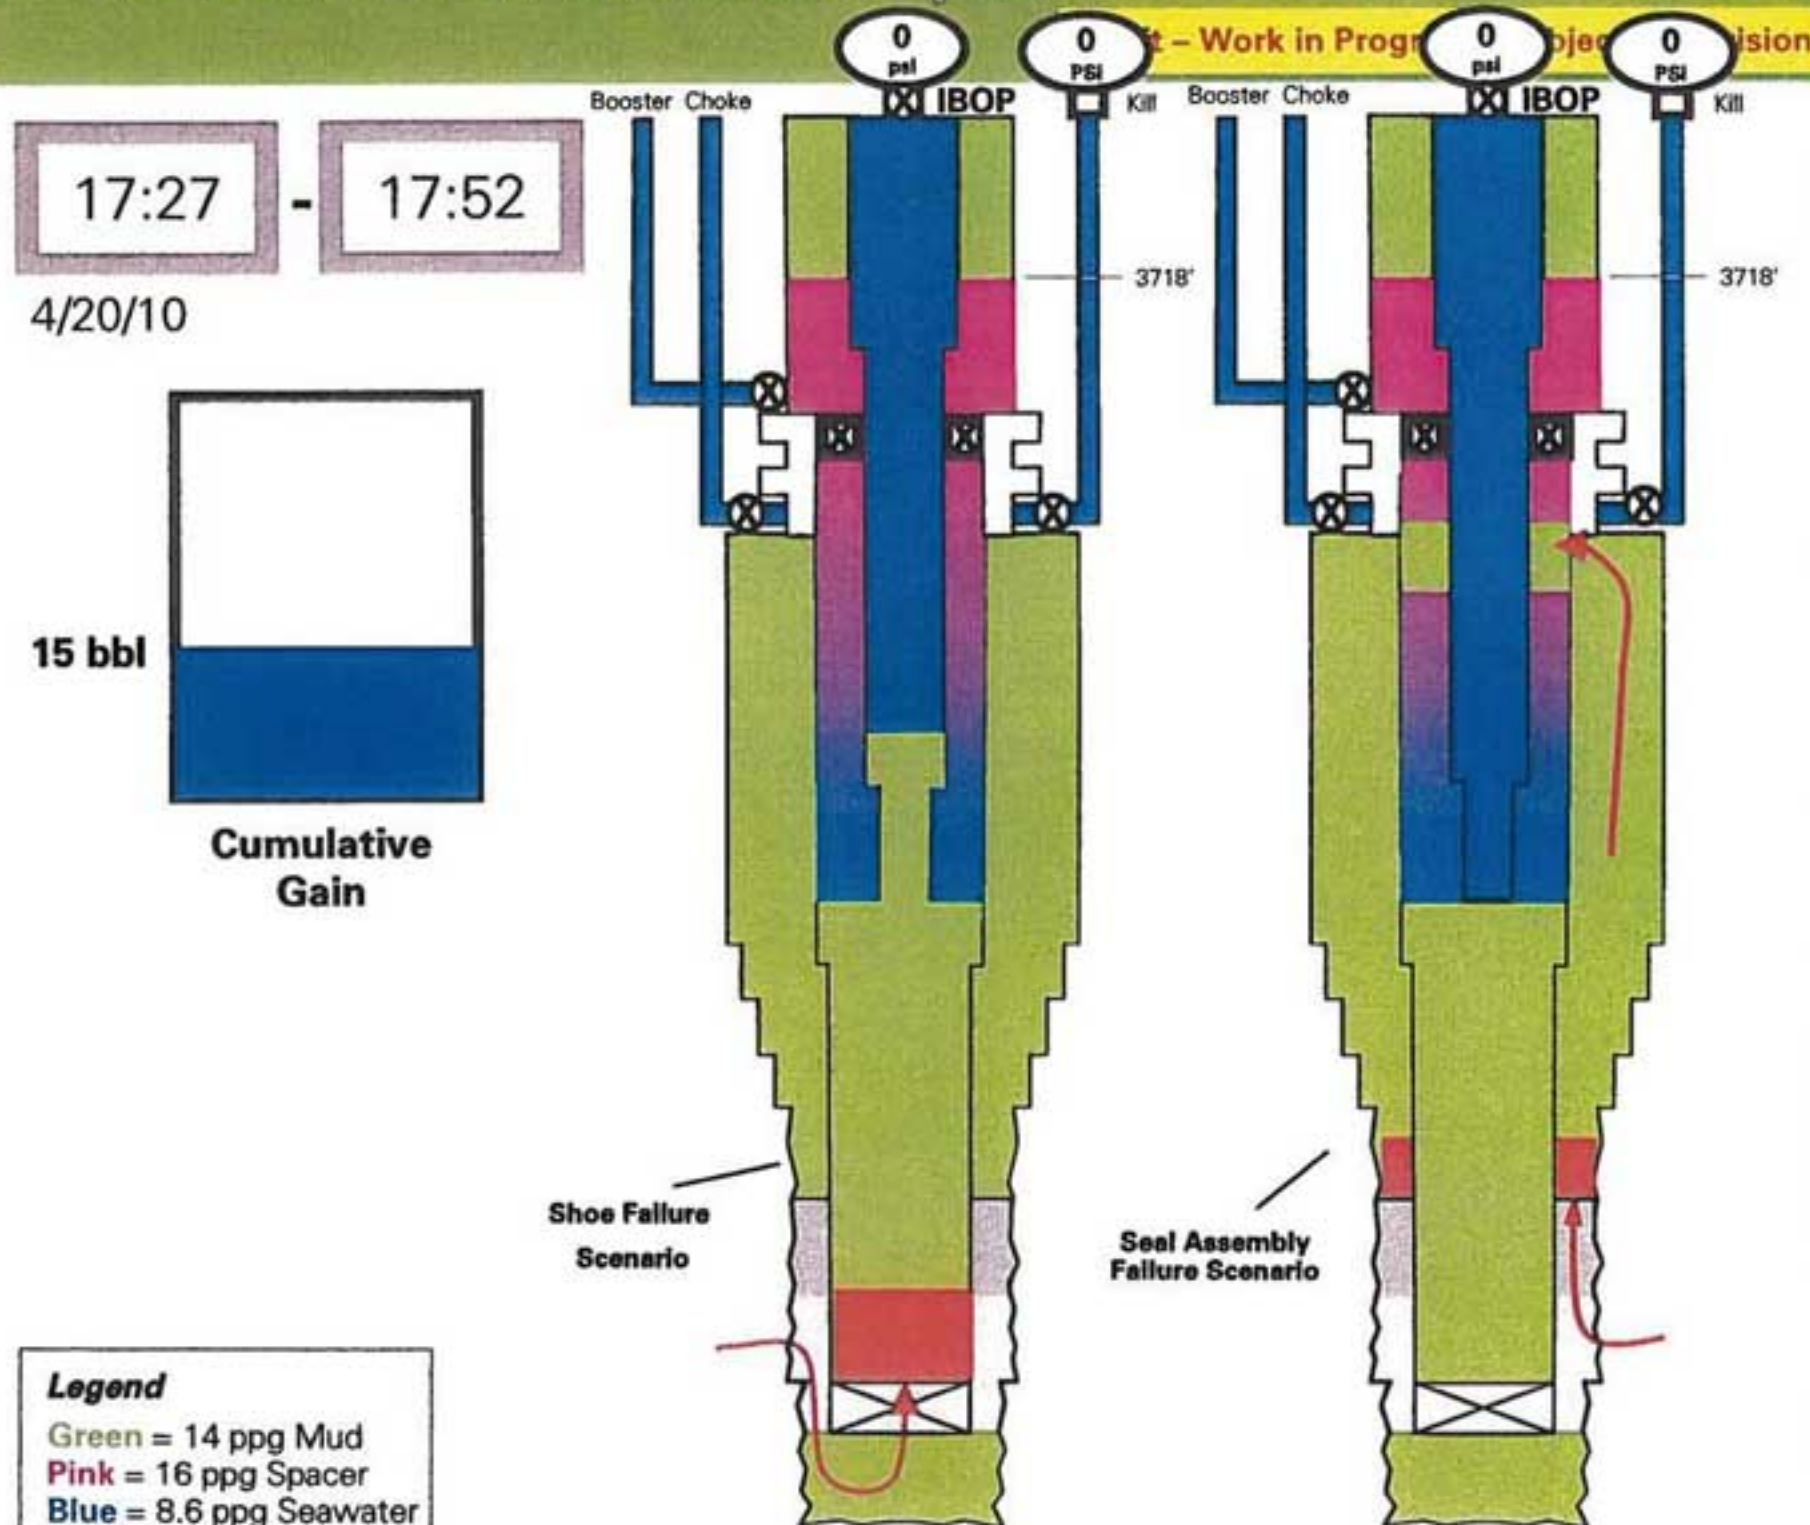
Bleed from 1202 to 0 psi

- Bleed drillpipe from 1202 to 0 psi
- IBOP is then closed

- Witness statements indicate 15 bbls taken at this bleed
 - Normal compressibility would be approximately 5 bbls
 - Influx from the well is suspected

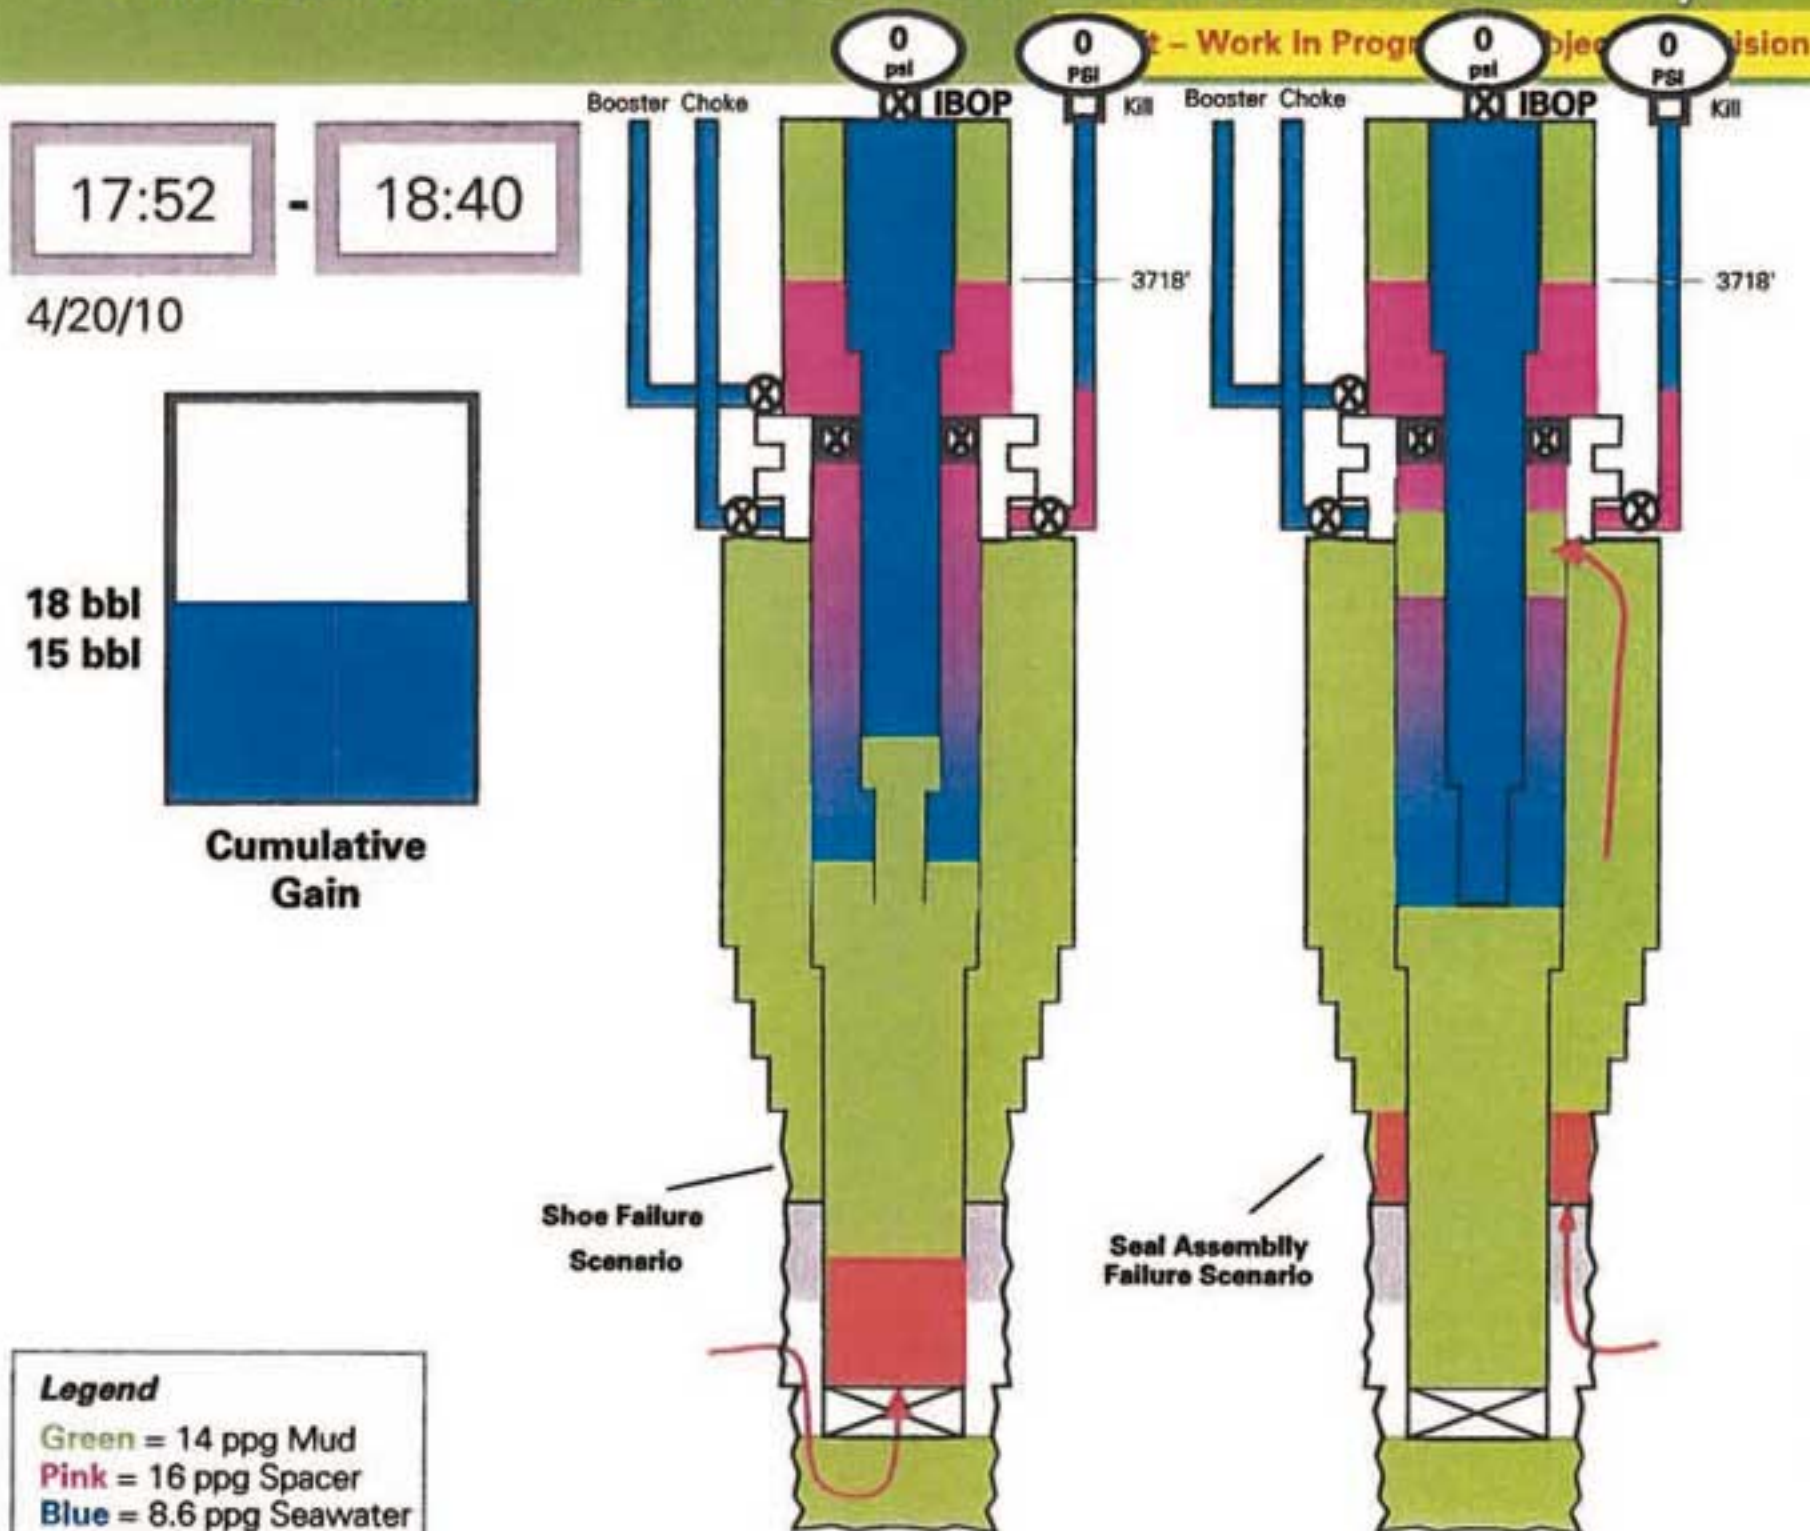
Bleed Kill Line / Pressure Builds Gradually

- Pressure monitored through cement unit quickly rises to 790 psi and falls
- Pressure slowly builds from 0 to 1400 psi over 31 minutes

- Start monitoring drillpipe pressure at cement unit
- Bleed 3-15 bbls from kill line to cement unit
- Cementer witness statement that well continued to flow and spurted
- Shut kill line and see pressure build

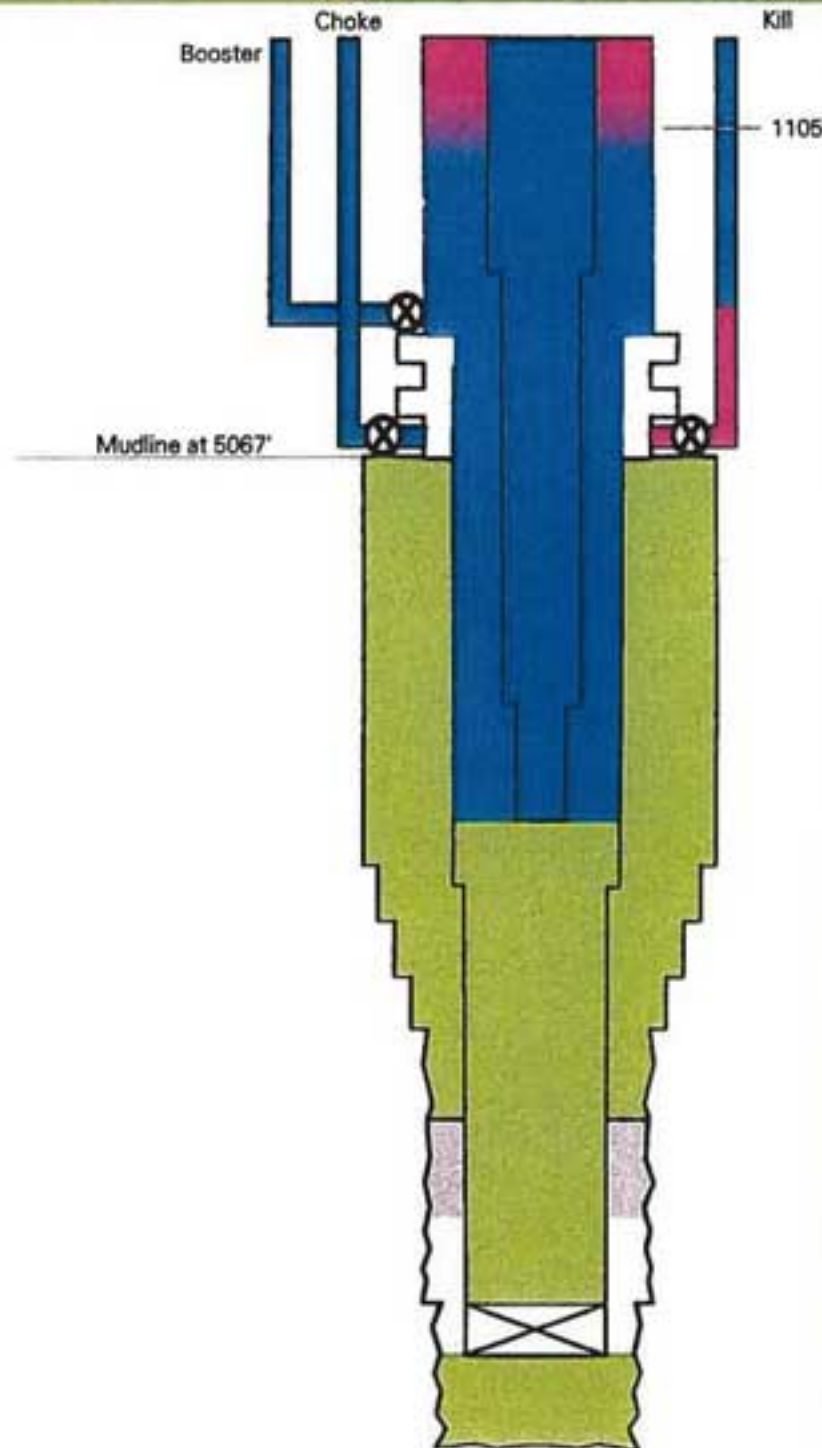
Displace to Seawater

- Pumped 1304 bbl seawater
 - Using rig pumps and booster
- Shut down for sheen test – spacer back
 - 1017 psi on DP when shut down
- Sheen test passes
- Crew instructed to divert returns overboard

- Flow out greater than flow in commencing at 20:58 while slowing pumps for spacer return
- Second indication of flow at 21:08 when pumps shutdown for sheen test
 - Pressure builds to 1263 over 5.5 minute period
 - Flow meter indicates well flowing

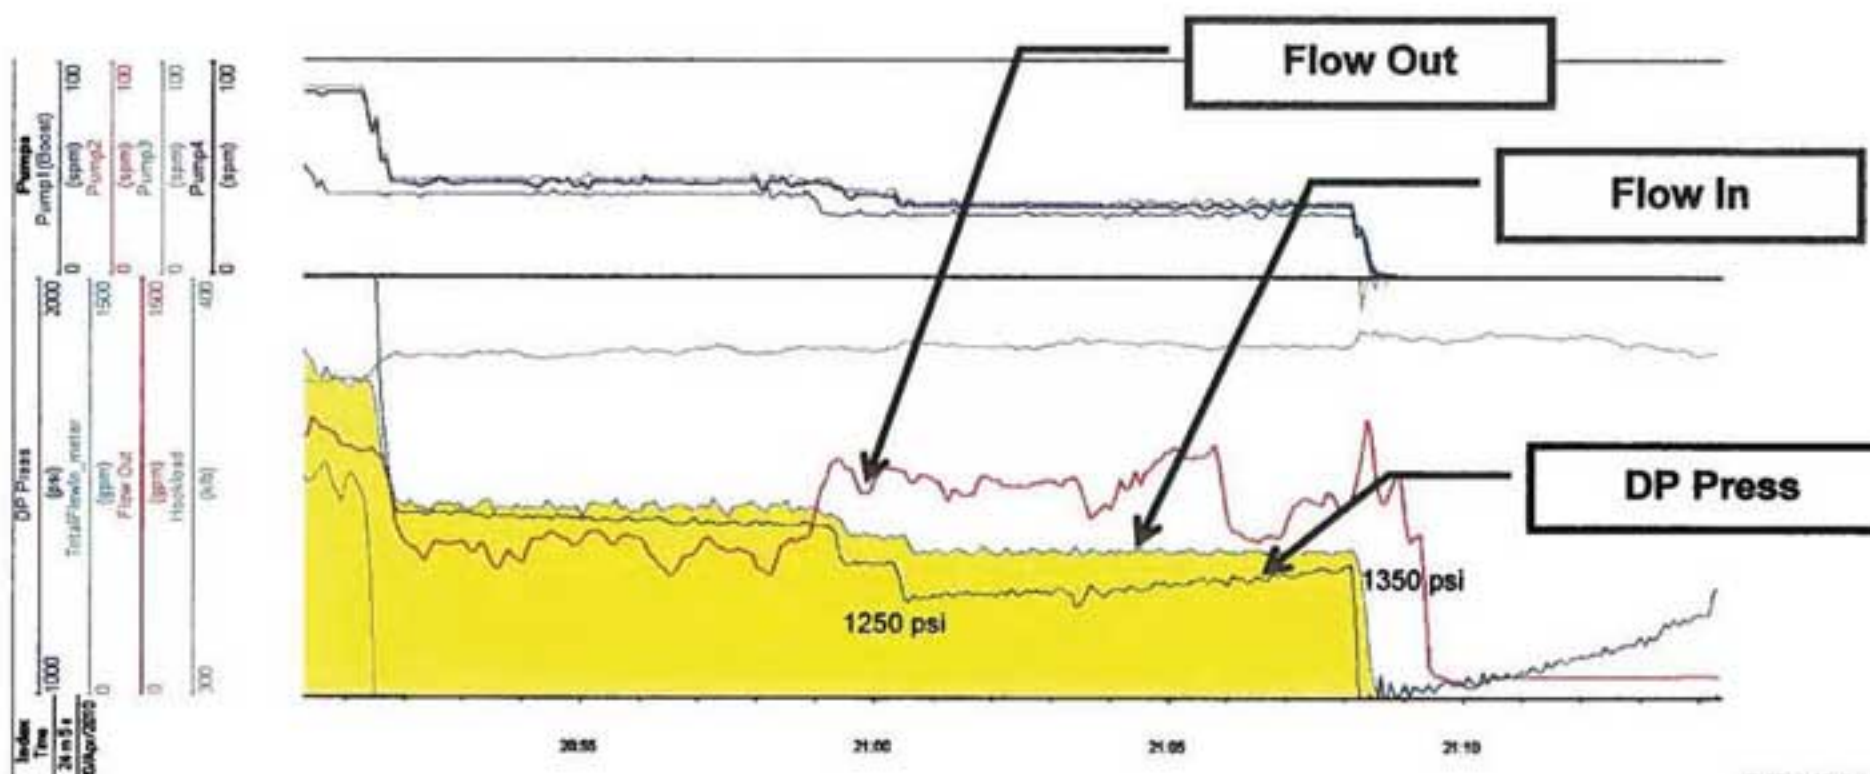
Critical Factor 2: Flow Indication #1 51 minutes before explosion

- Following final integrity test of wellbore, BOP annular was opened and well displacement of mud to seawater began:
 - Flow-out volume of mud and drillpipe pressure showed expected correlation until about 20:58
 - At 20:58, pumps were slowed and the following abnormal results:
 - Drillpipe pressure increased from 1250 psi to 1350 psi
 - Flow-out volume increased instead of slowing
 - Flow-out vs flow-in shows gain of approx 57 bbls over 12 minute period
 - First indication of flow ~51 minutes before the explosion
