Washington Briefing
Deepwater Horizon Interim Incident Investigation

24th May 2010

Deepwater Horizon Incident Timeline and Animation of Events

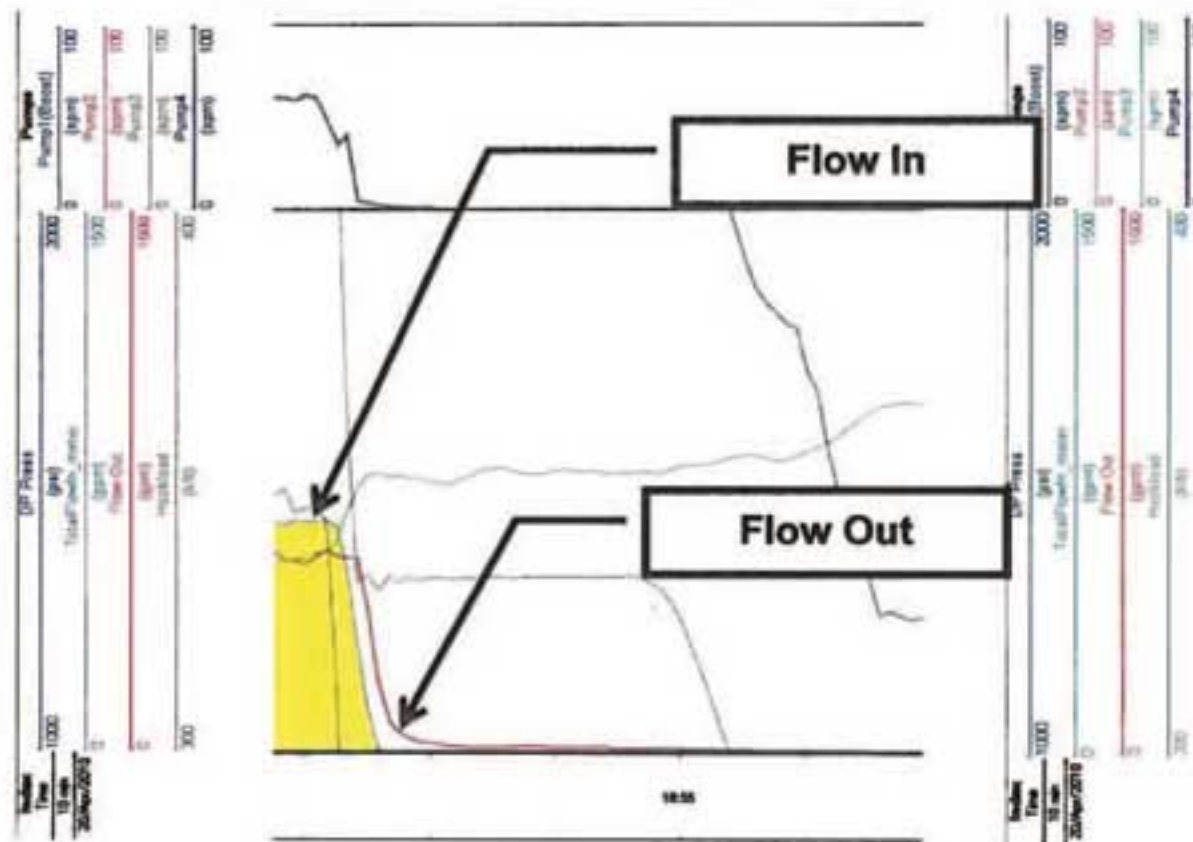
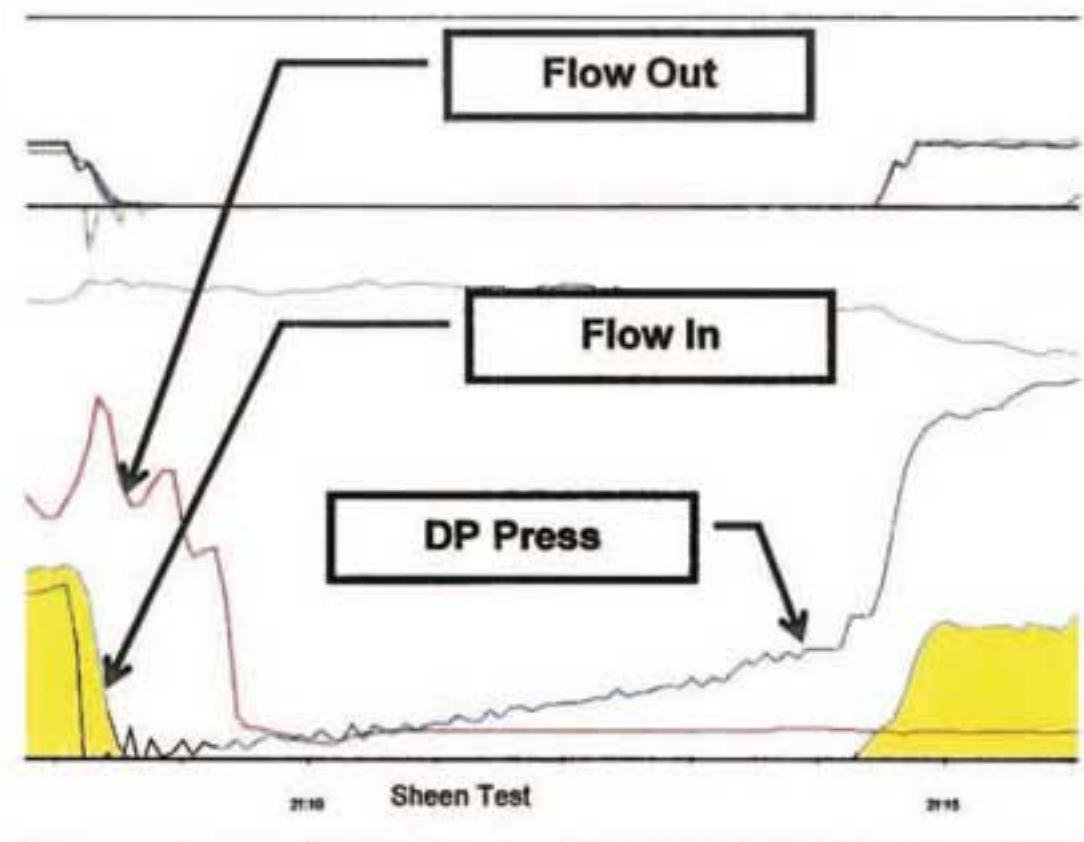
Critical Factor 2: Flow Indication #2 41 minutes before explosion

- At 21:08 – pump shutdown as spacer observed at surface. Sheen test required.
 - Flow-out should be zero, but real-time data indicates well flowing after pump shut off
 - Drillpipe pressure increased from 1017 psi to 1263 psi over 5.5 minute period of sheen test

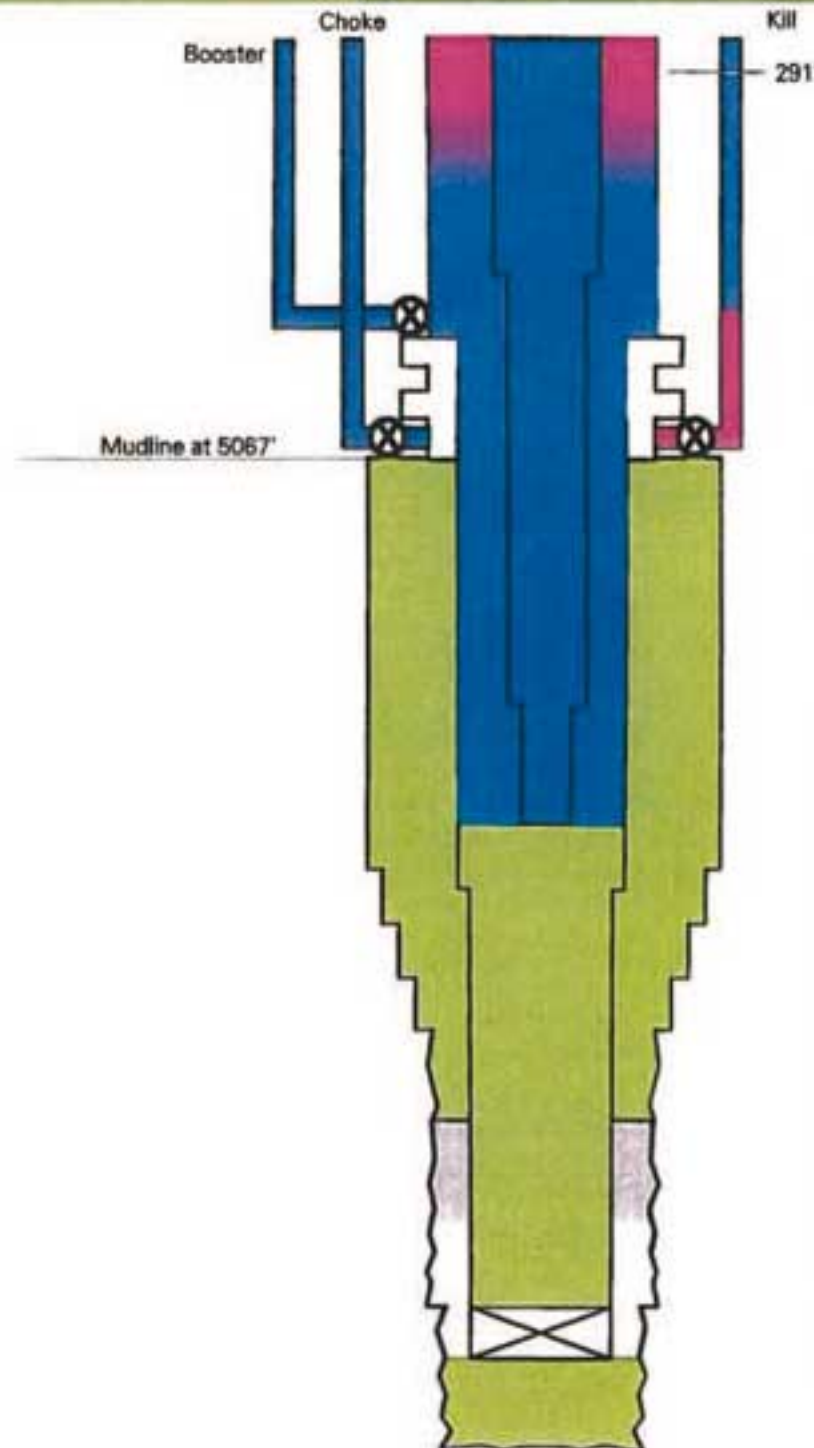
Resume Displacement

- Resume displacement
 - Pump another 265 bbls
 - Returns going overboard
 - Flow meter bypassed – unable to monitor flow out
- Pumps stop at 21:31
- Significant pressure buildup starting at 21:47
- Data lost at 21:49
 - Last pressure reading 5700 psi

- Pumps stop at 21:31 – suspect problem identified with well
- 4 calls made from rig floor and Chief Mate discusses well with Toolpusher on rig floor
- Suspect explosion at 21:49
- EDS at 21:56 by Captain

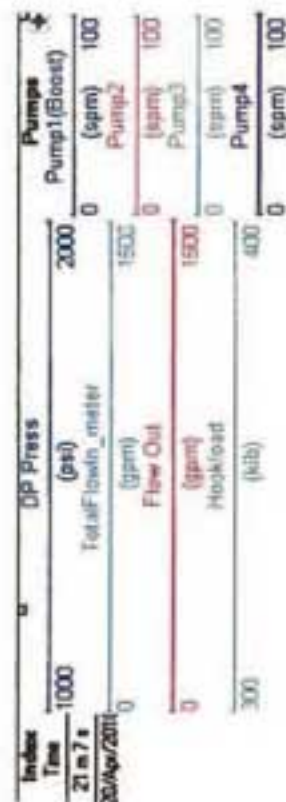
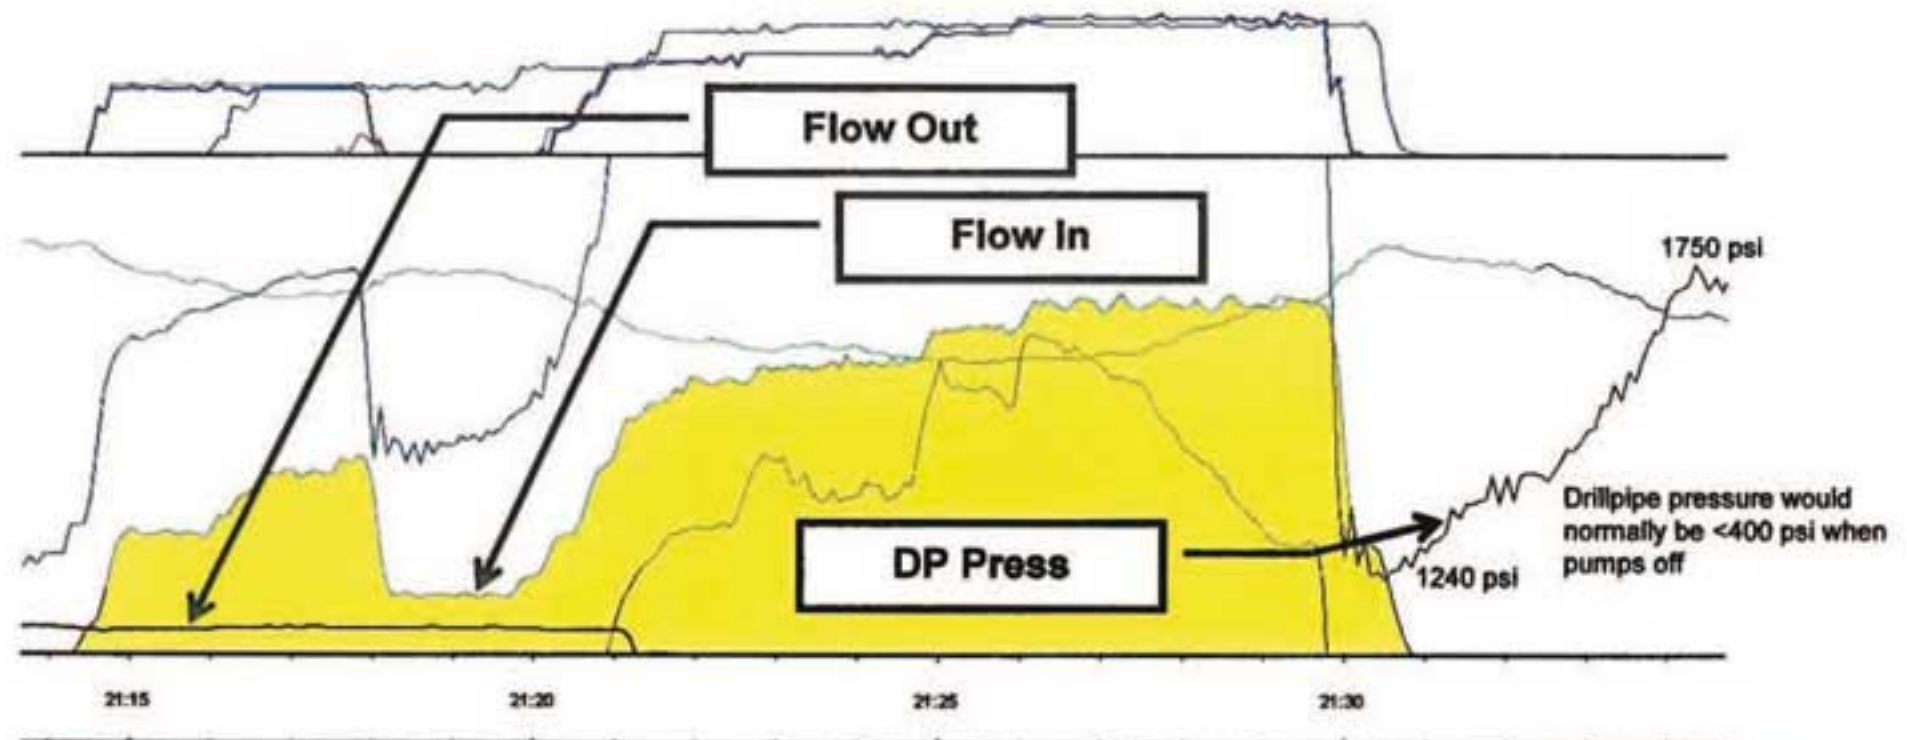
Critical Factor 2: Flow Indication #3 18 minutes before explosion

- Sheen test passed and approval granted to discharge overboard
- At 21:14, pumping resumed to continue displacement to seawater
- At 21:31, problem observed (e.g. mud returns, abnormal pressures)
 - Pump abruptly shutdown
 - Drillpipe pressure at time of shutdown was 1240 psi. Increased to 1750 psi over next 6 minutes.
 - Flow-out data not available due to fluids being discharged directly overboard (bypasses flowmeter)
