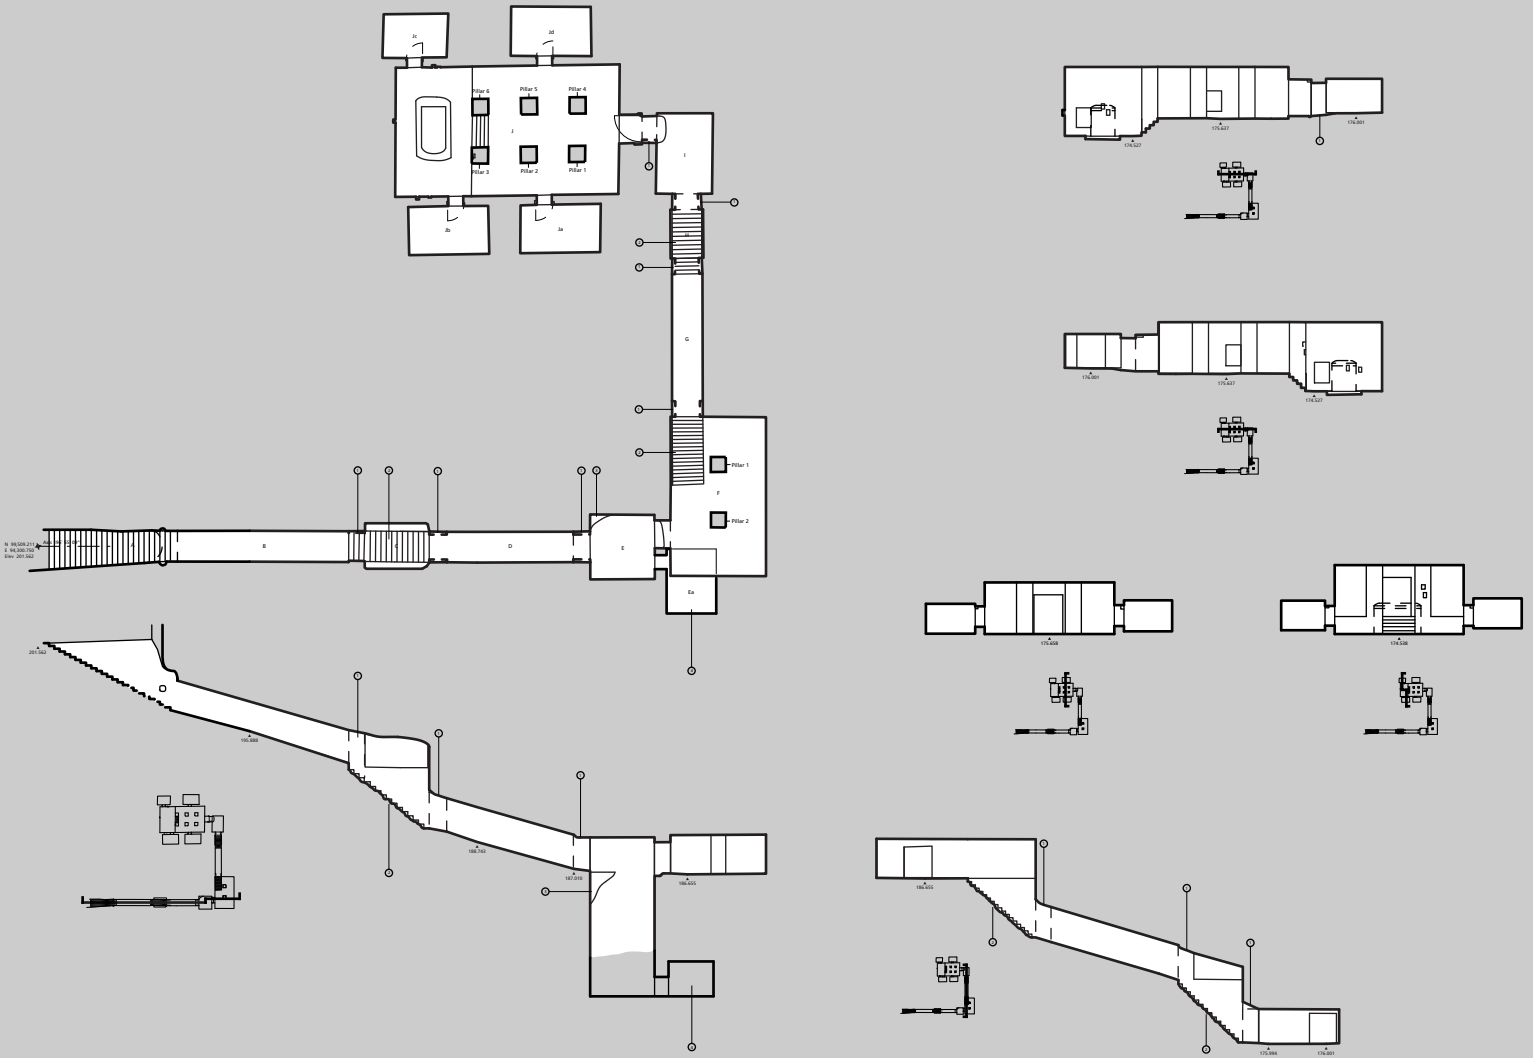
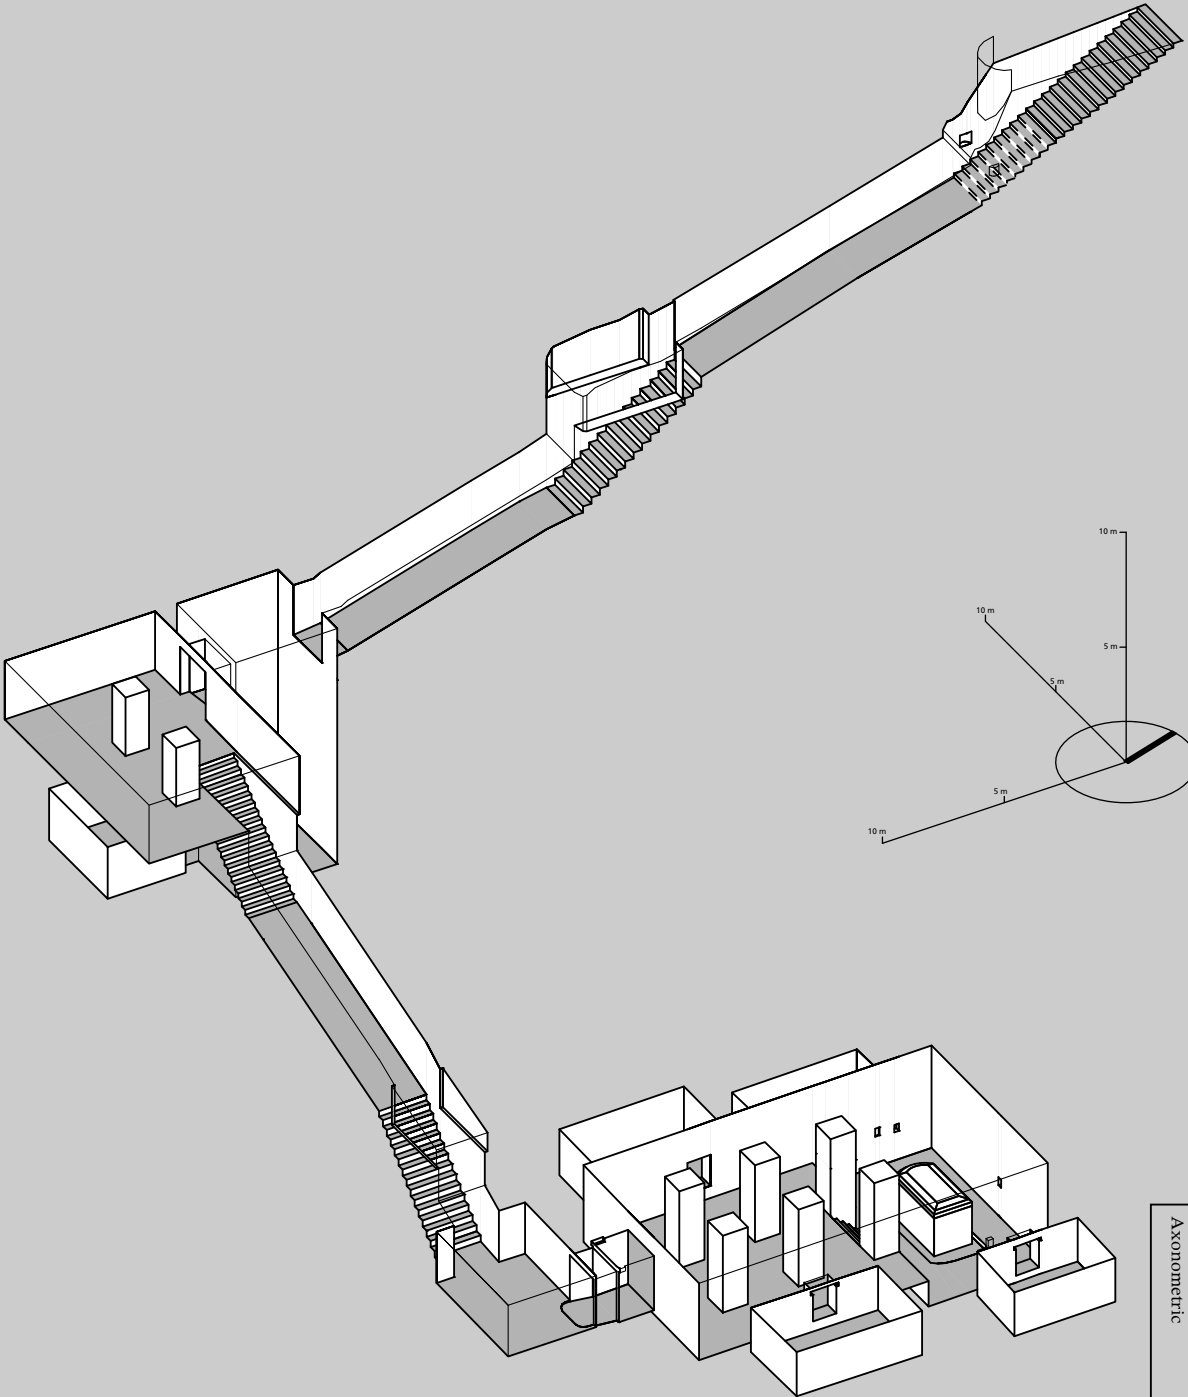
NOTES	
1	Excess joints cut back at gates C to D and gates D to E.
2	Original shape badly damaged.
3	Unfinished cutting of corner of shaft.
4	Access to chamber is generally blocked by debris in the shaft.
