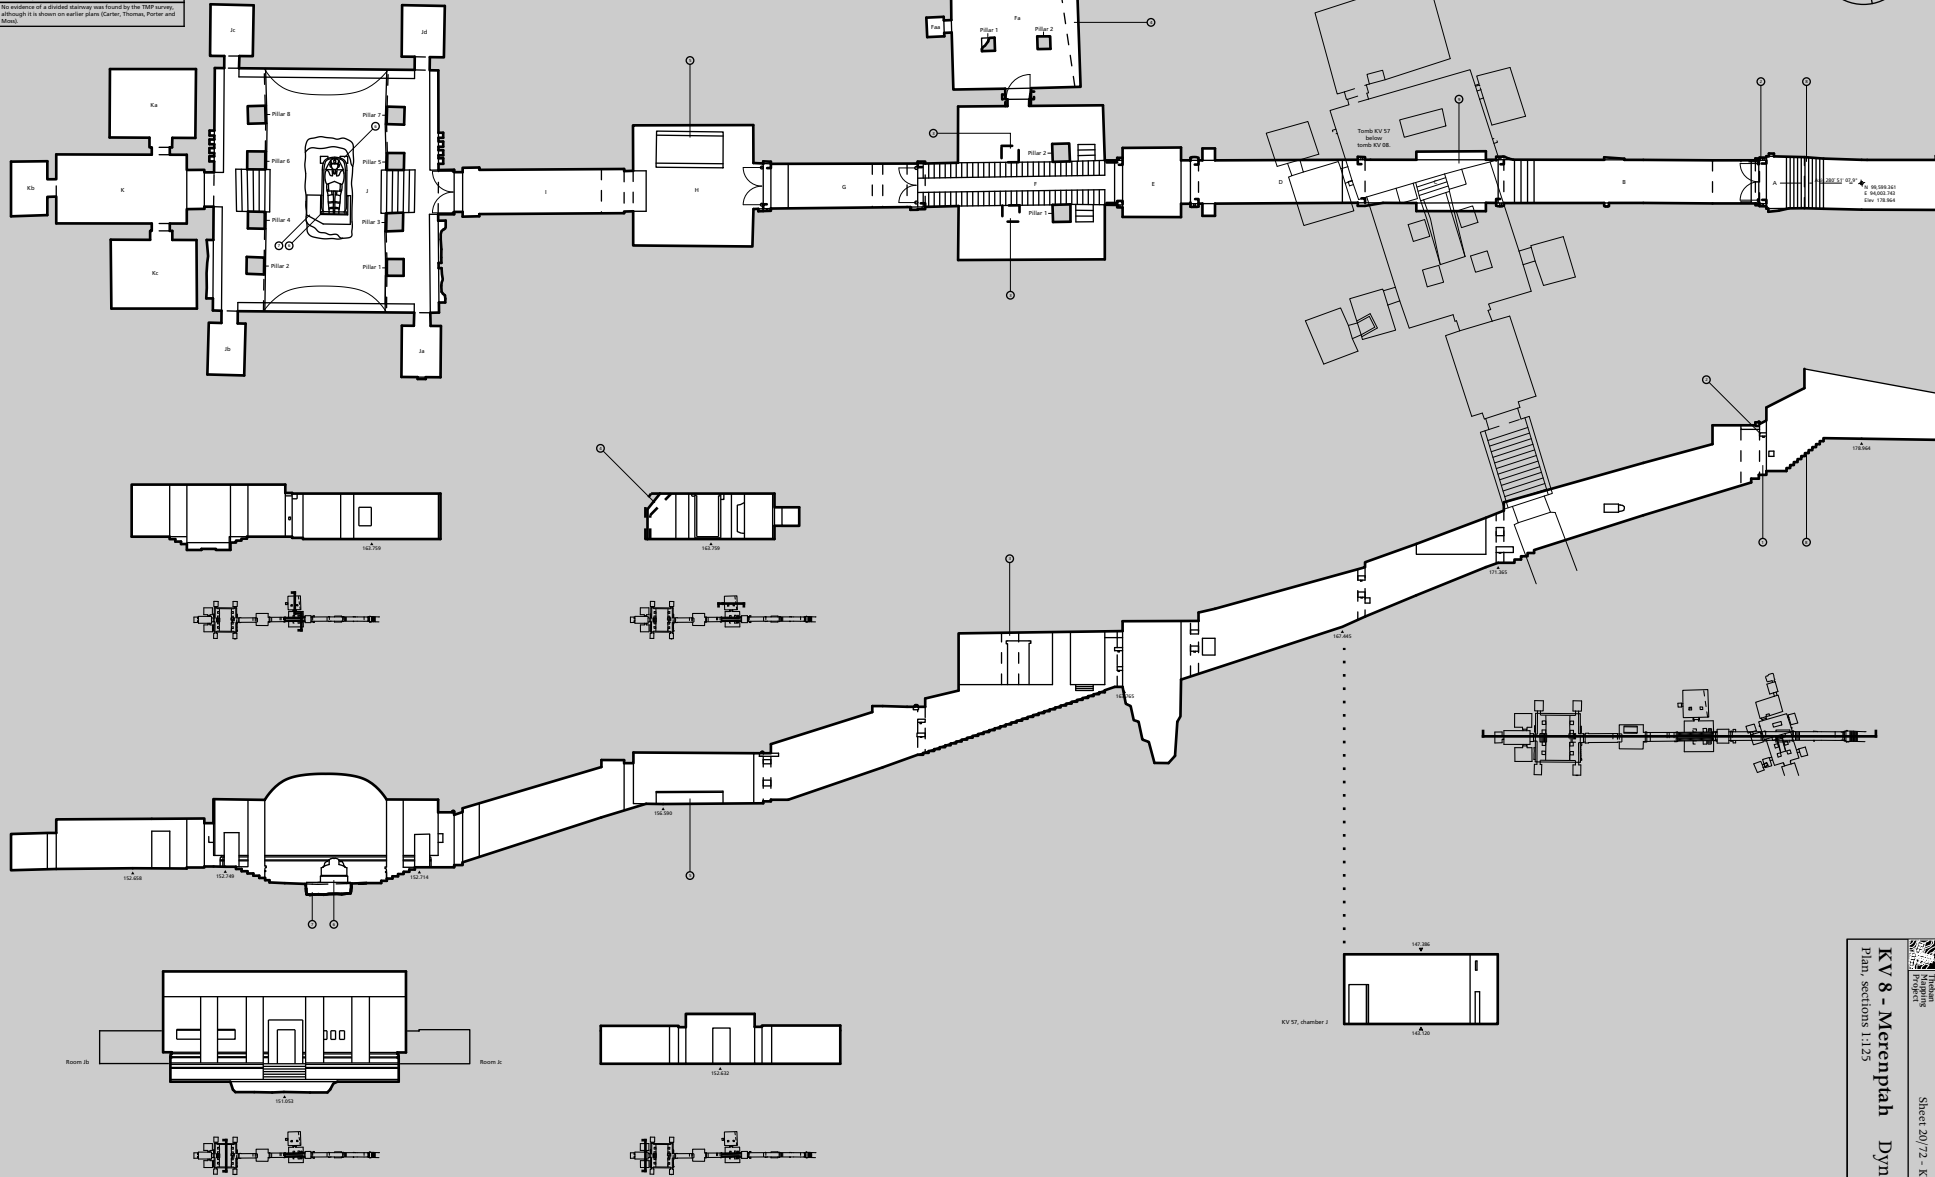
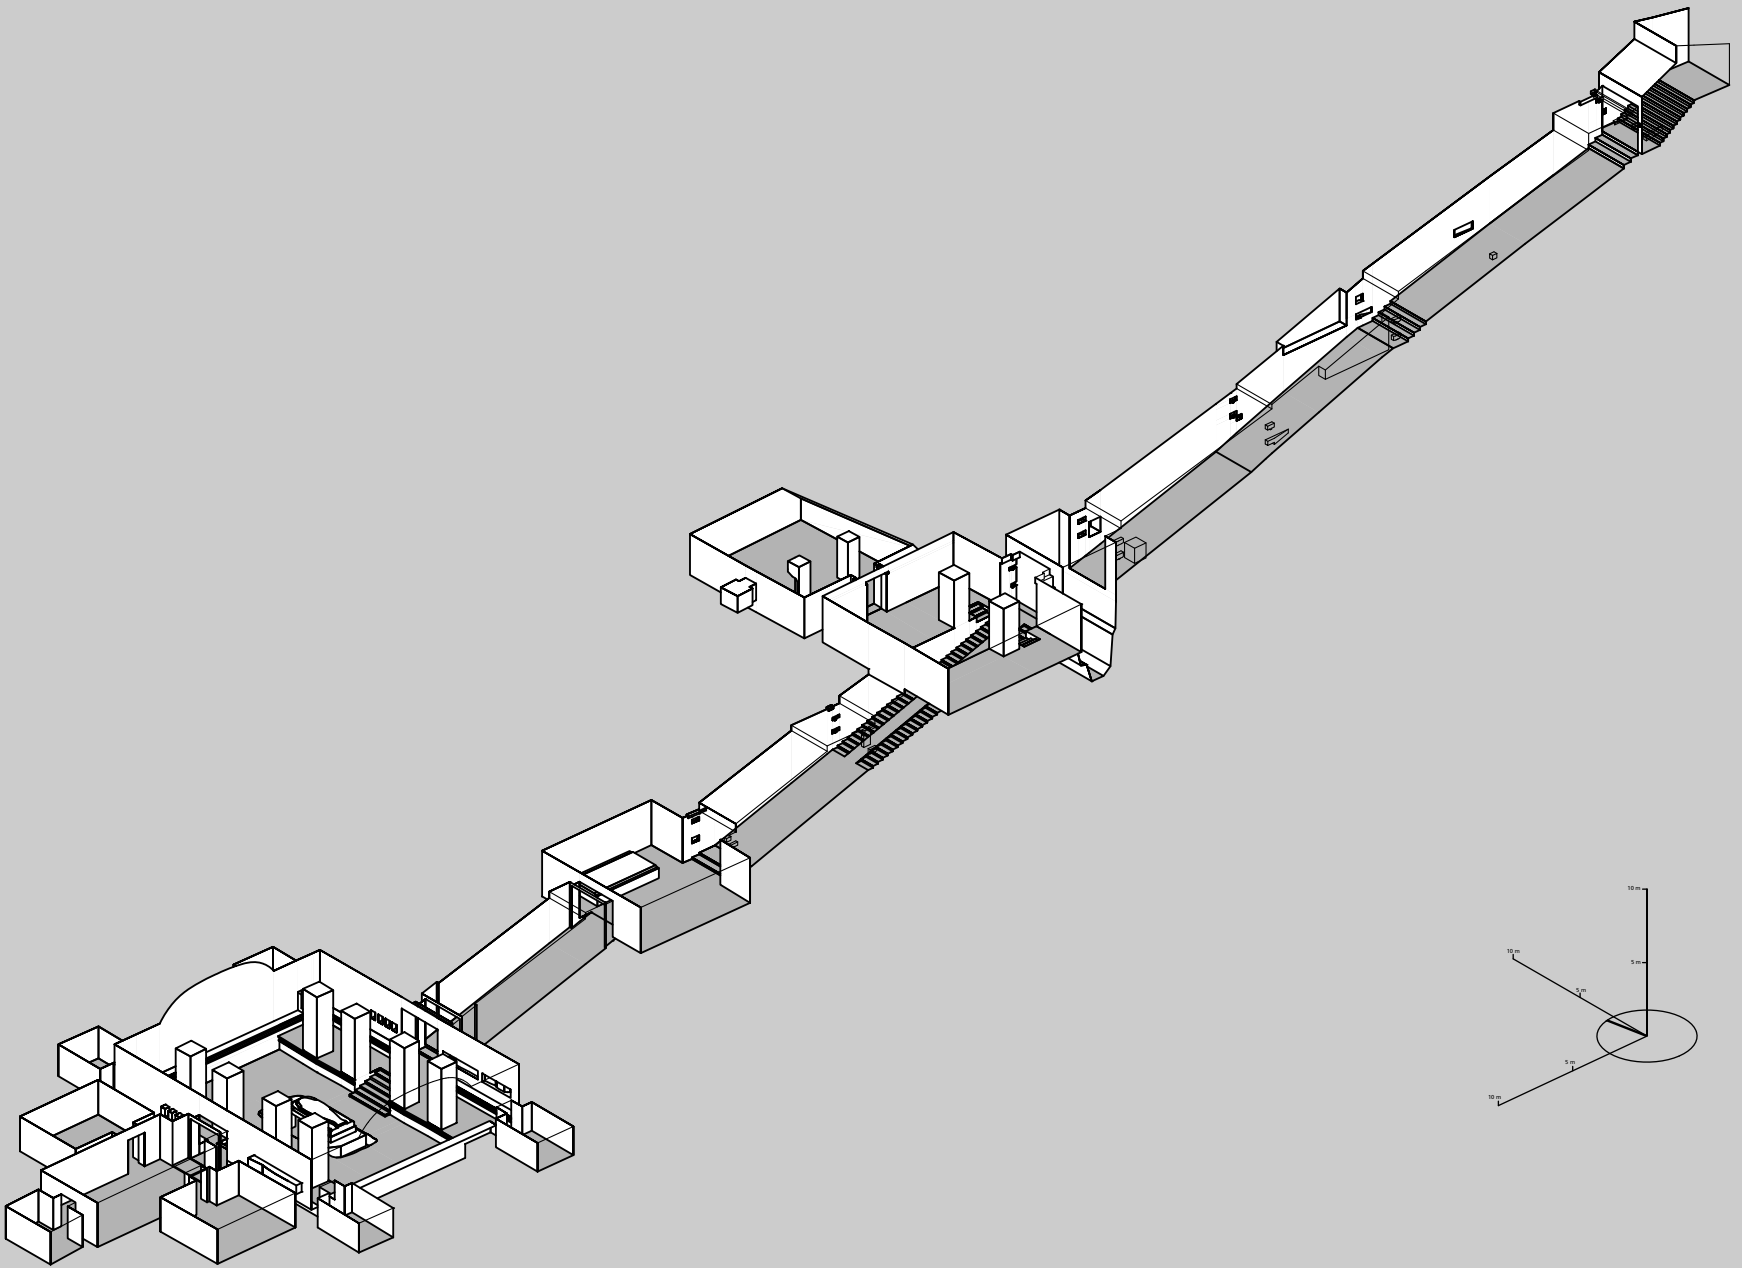
- Notes
1. Other pillars cut away at gates B to H.
 2. Slotted socket for dowel cramps to hold in place sandstone block replacements of original door pivots (at gates B to H).
 3. Traces of pillar rooted in ceiling. Recently plastered over.
 4. Clipping away of hardened concrete deposits that impeded entry of the chamber.
 5. Red granite lid of outer sarcophagus removed here during the removal of the third sarcophagus to Tanks in Dynasty XXI.
 6. Modern concrete base for the red granite lid of the second sarcophagus.
 7. Colored blocks, part of the original (pink) for the set of sarcophagi.
 8. Modern steps.
 9. No evidence of a divided runway was found by the TMP survey, although it is shown on earlier plans (Carter, Thomas, Foster and Mace).
