KV 35 - Amenhetep II Dyn. XVIII
Axonometric

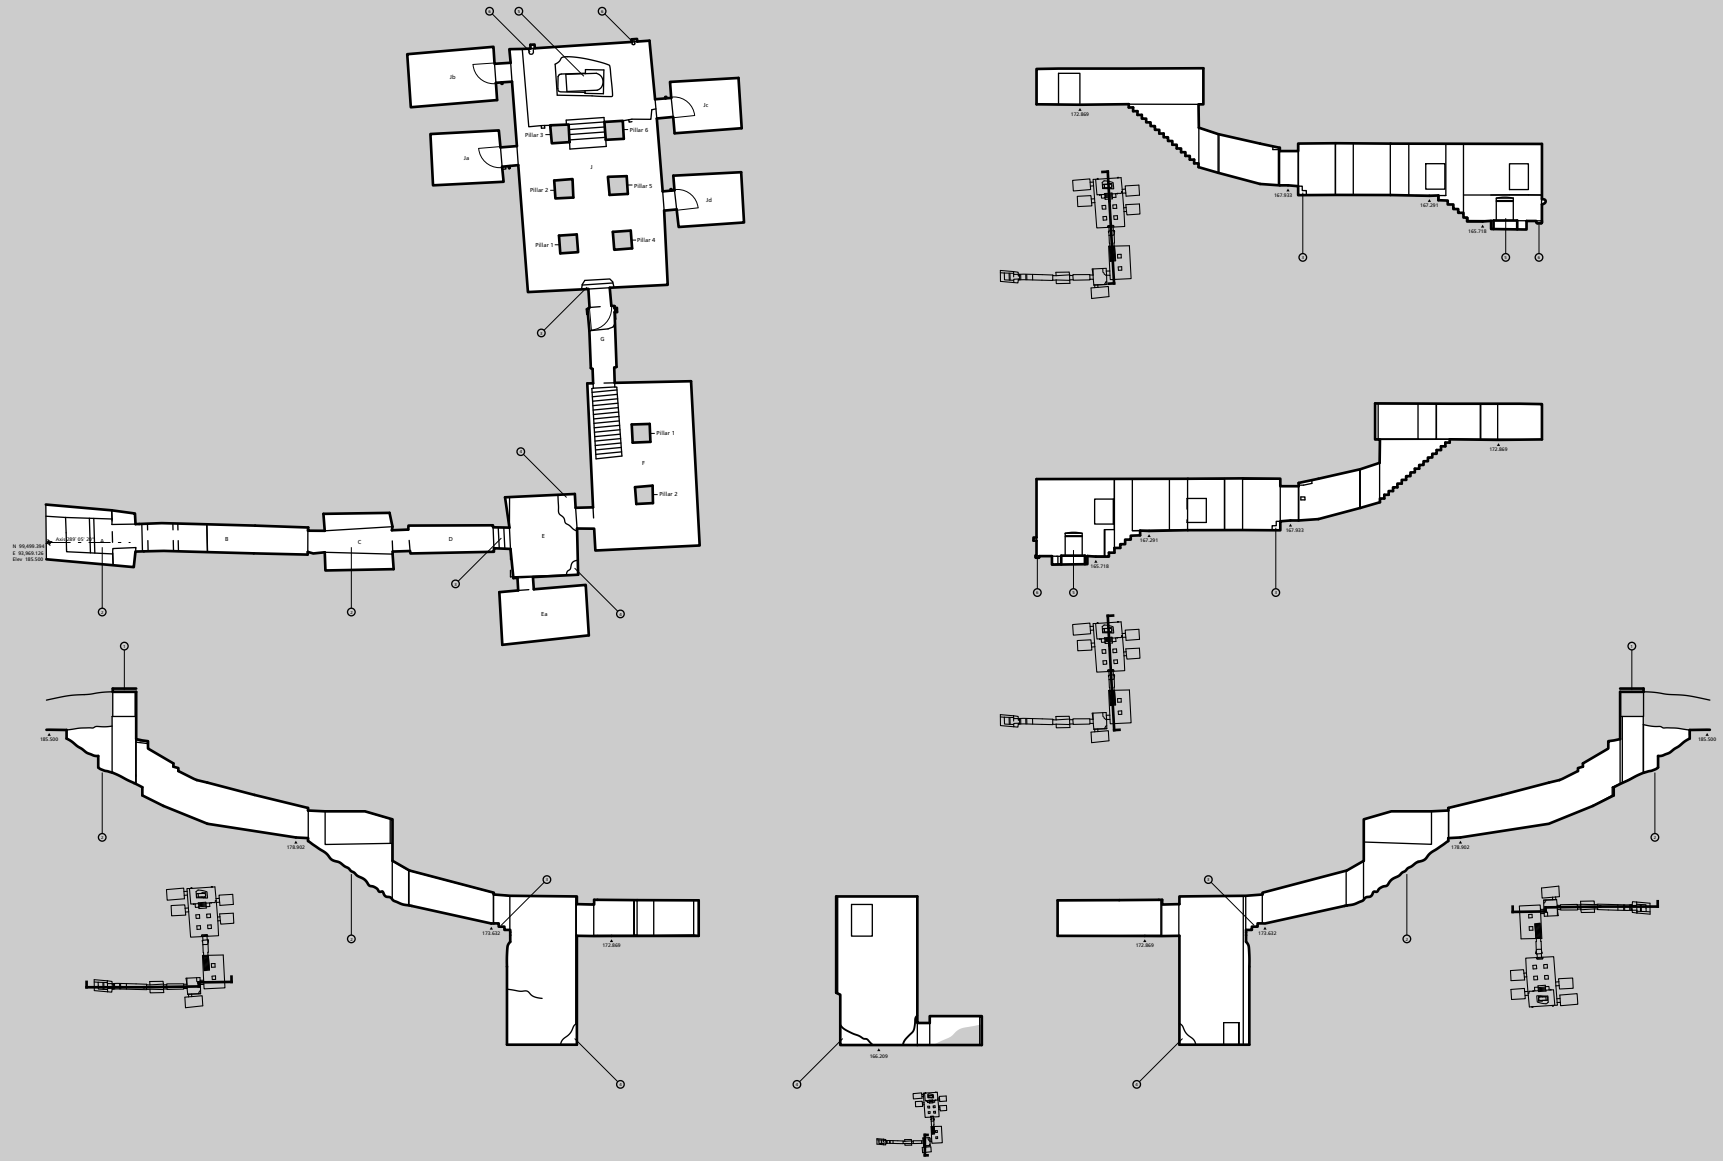
NOTES	
1.	Modern concrete shelter protecting entrance from falling rock.
2.	Precinct stairs badly damaged.
3.	Modern steps.
4.	Unexcavated debris.
5.	Sarcophagus rests on limestone piers placed in situ.
6.	Shallow pits on floor.
