Washington Briefing
Deepwater Horizon Interim Incident Investigation

24th May 2010

Deepwater Horizon Incident Timeline and Animation of Events

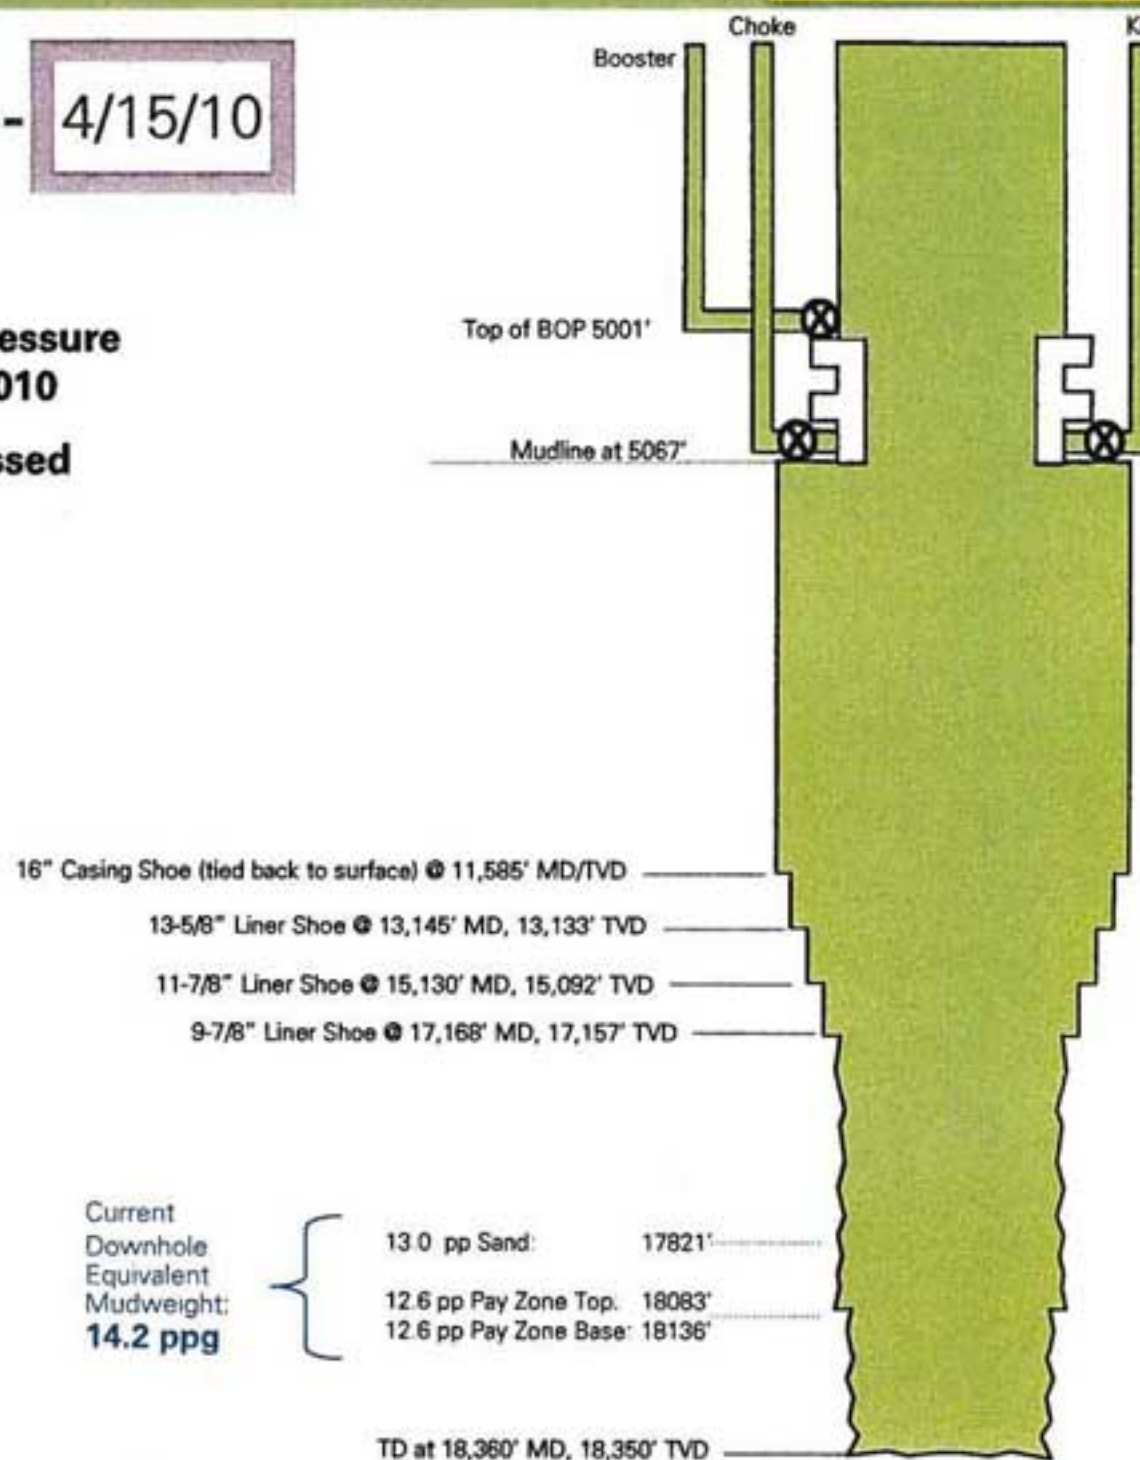
Last BOP pressure
test: 4/10/2010

All tests passed

- **Finish drilling**
 - 9-7/8" x 8-1/2" open hole
 - 14.0 ppg mud inside and out
- Trip out with drilling assembly
- Wireline log for 4 days

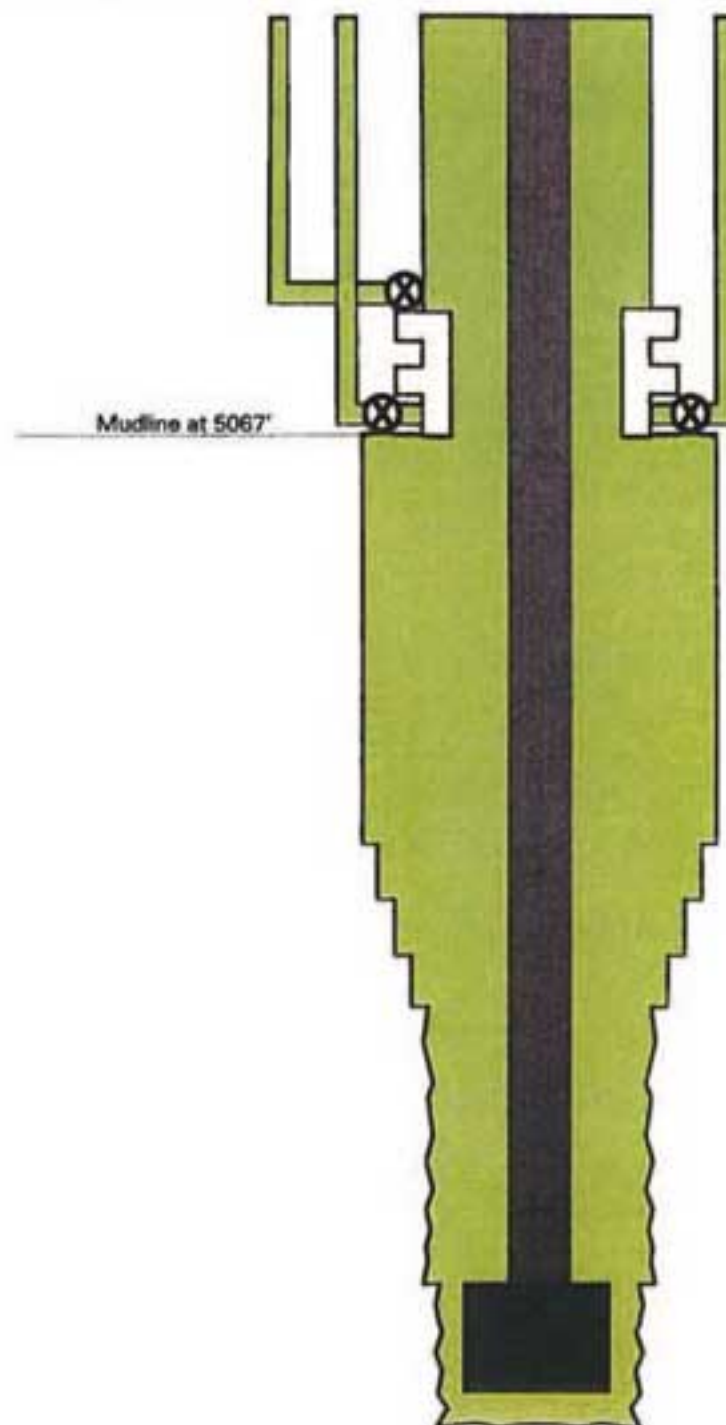
Function test BOP:
4/17/10 at 01:00

Function test diverter:
4/17/10 at 01:30

- Run in hole for wiper trip
 - Circulate bottoms up at TD
 - Pump high vis sweep
 - Monitor for gains or losses – none
 - 14.0 ppg clean mud throughout before trip out
- Pump out from 18360' – 14759'
 - 4 flow checks during trip out – no flow

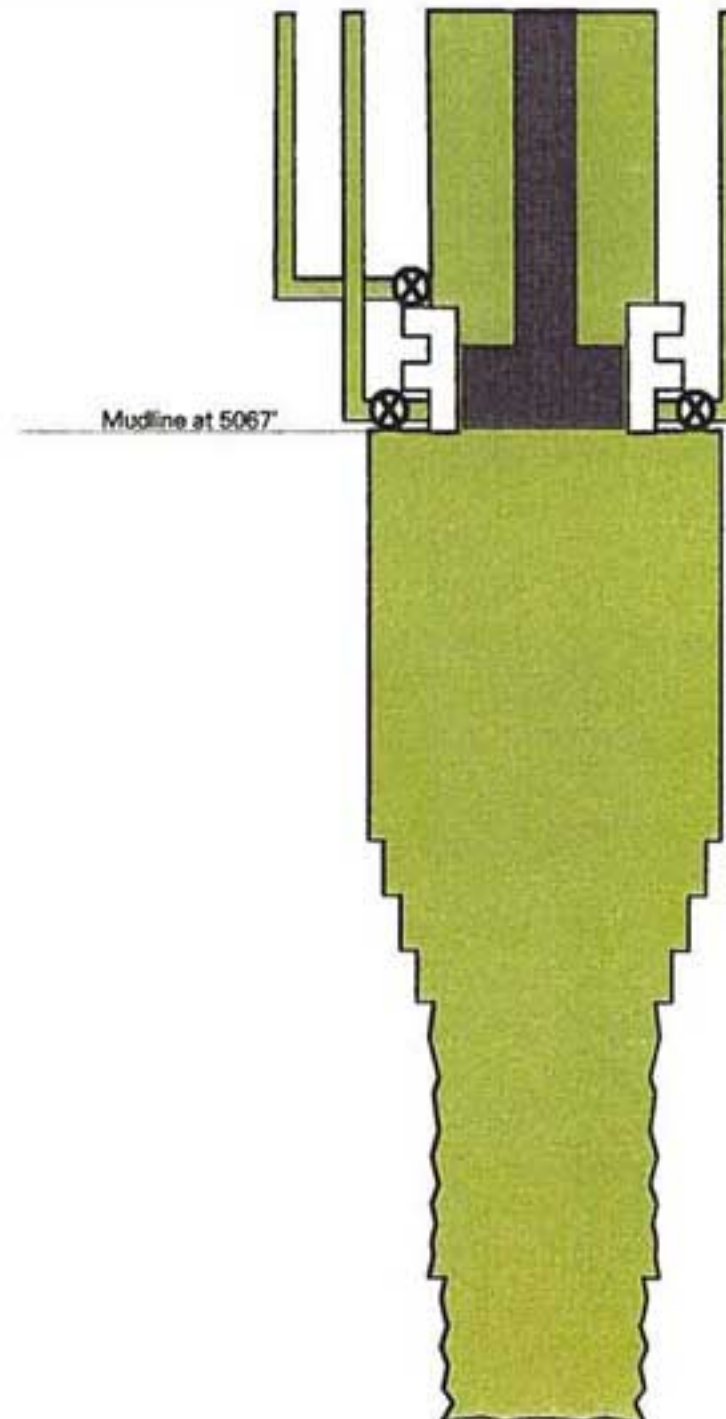
Retrieve Wear Sleeve

Function test BSR
4/17/10 23:00

- Make trip to retrieve wear sleeve
 - Retrieval successful

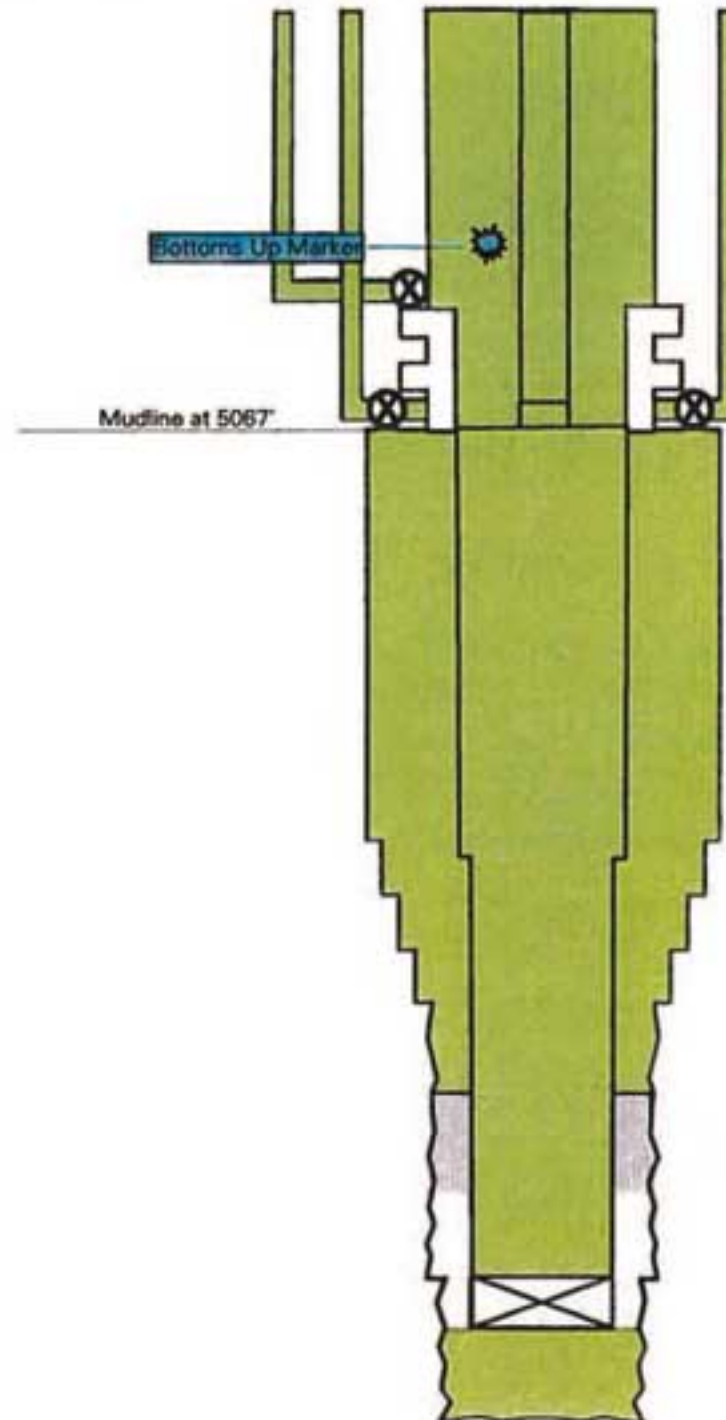
Close Upper VBR's to
test seal assembly.
Test successful

- Release running tool
- Set seal assembly at 5059' to seal the 9-7/8" casing annulus
- Successful pressure test of seal assembly
- Setting and testing procedure as per plan
- Begin tripping out

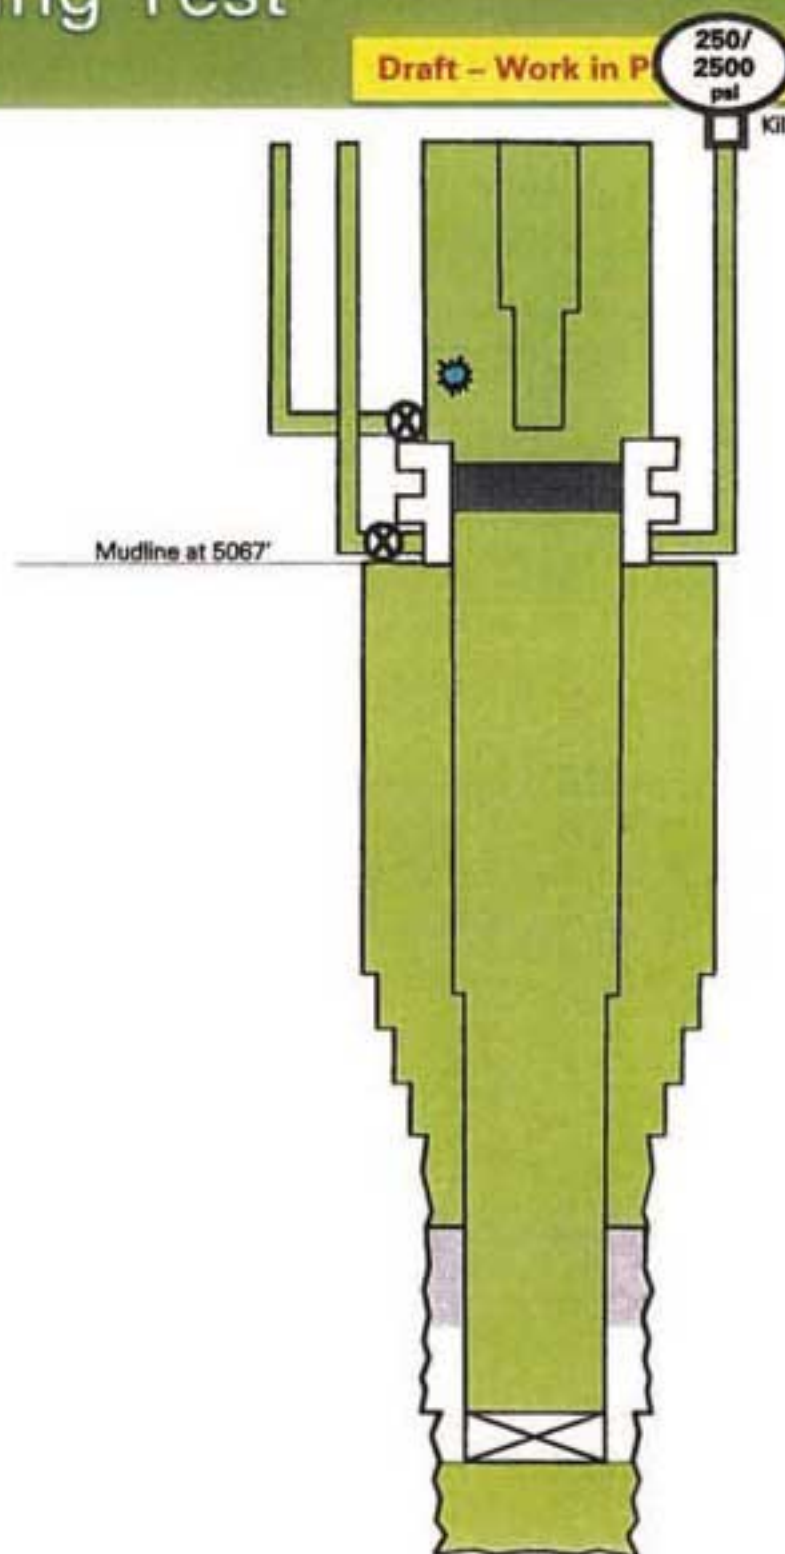
12:00 – Close BSR. Pump
down kill line to test
casing to 250/2500
psi for 30 min

- Run in with tapered string for cement plug:
 - 6-5/8" x 5-1/2" x 3-1/2" drill pipe
- Stop at 4700' (above BOP)
- Close blind shear rams
- Positive test casing to 250 and 2500 psi

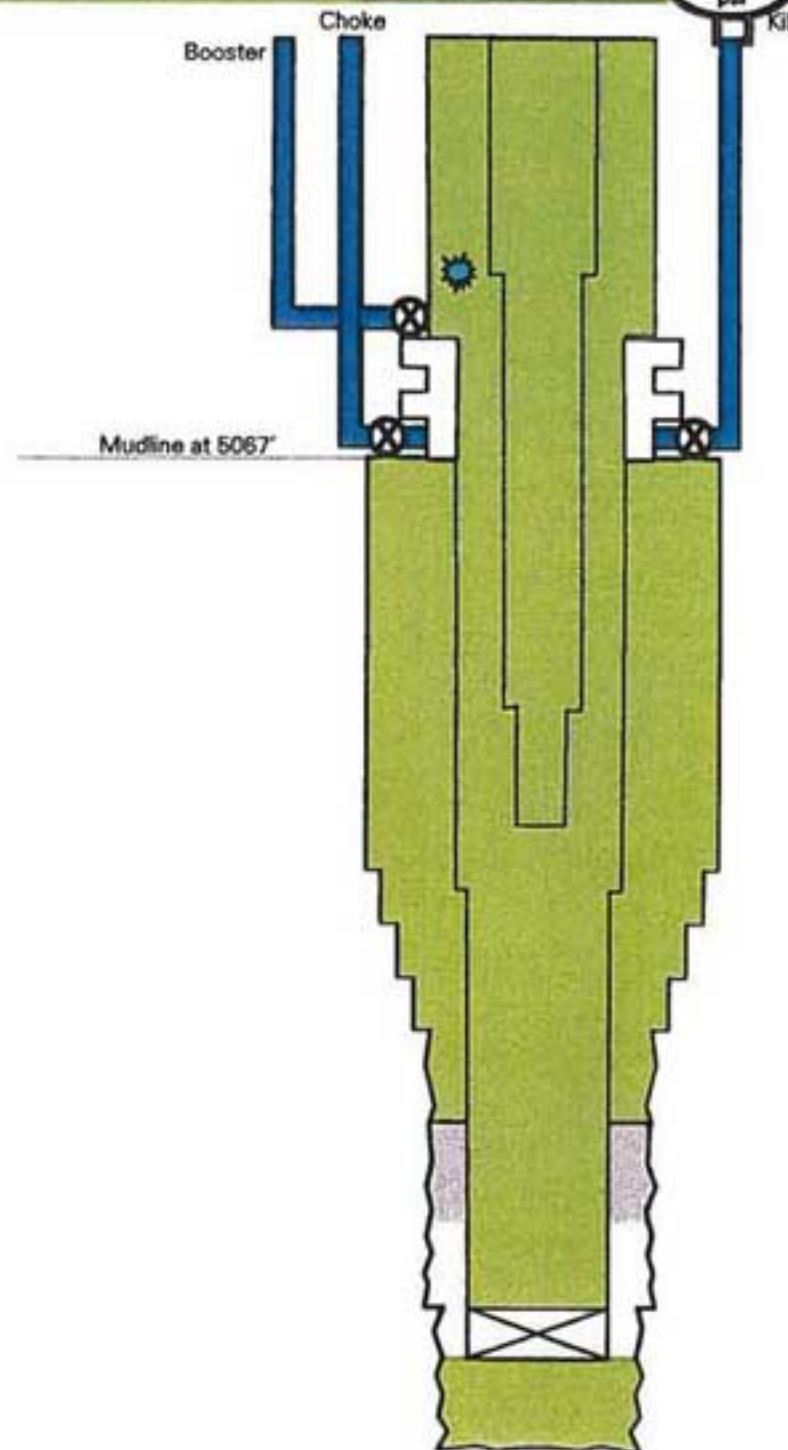
- Displaced booster line w/ seawater
- Displaced choke line with seawater
- Displaced kill line with seawater
- 1200 psi trapped in kill line

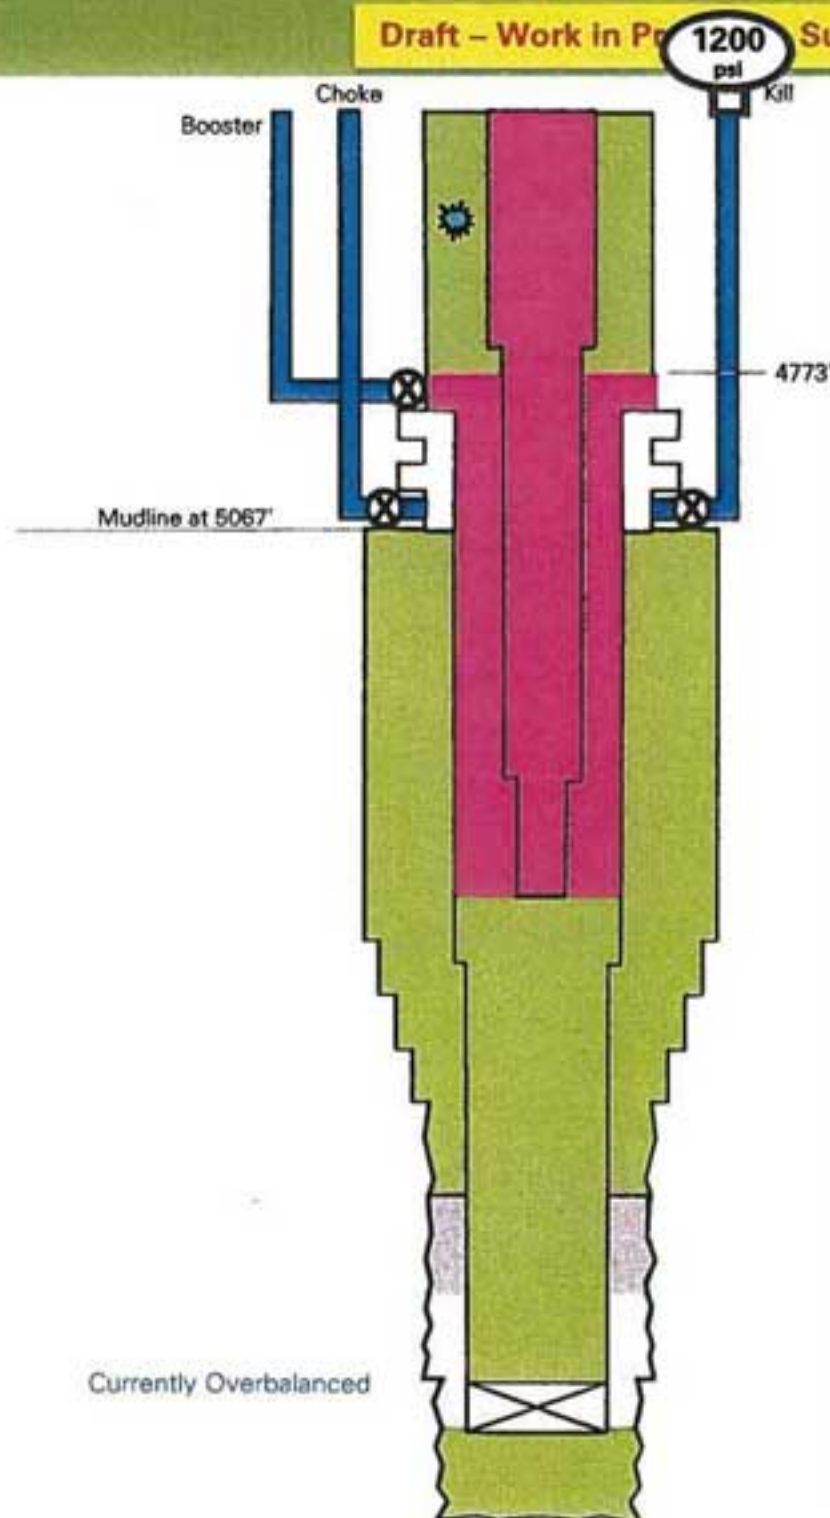
- Pump 454 bbls LCM spacer (16.0 ppg)
 - Form-a-Set + Form-a-Squeeze combination
 - Viscous, solids-laden fluid
- Kill line pressure holds at 1200 psi

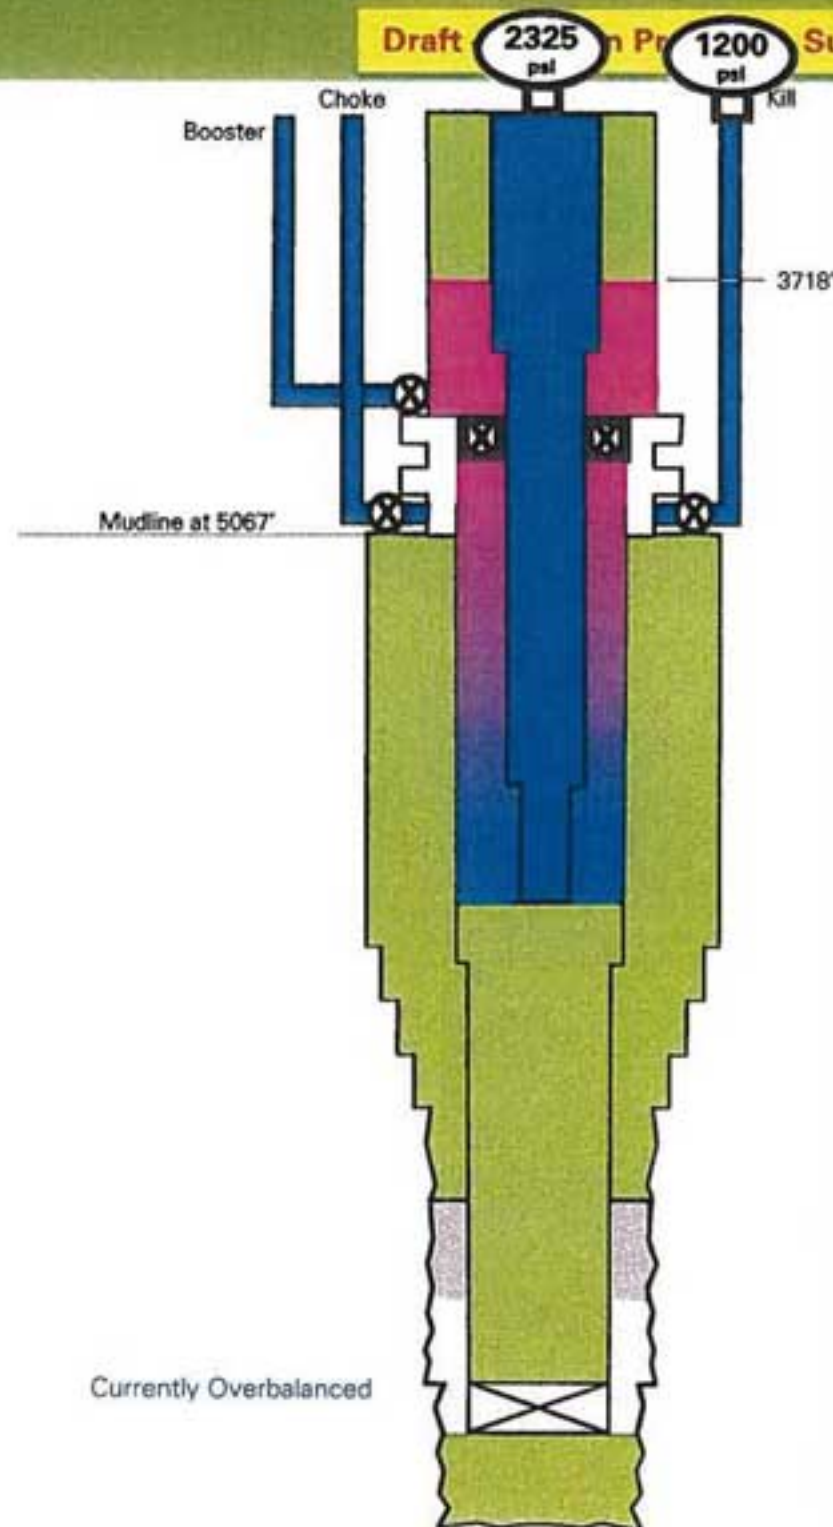
- Shut annular

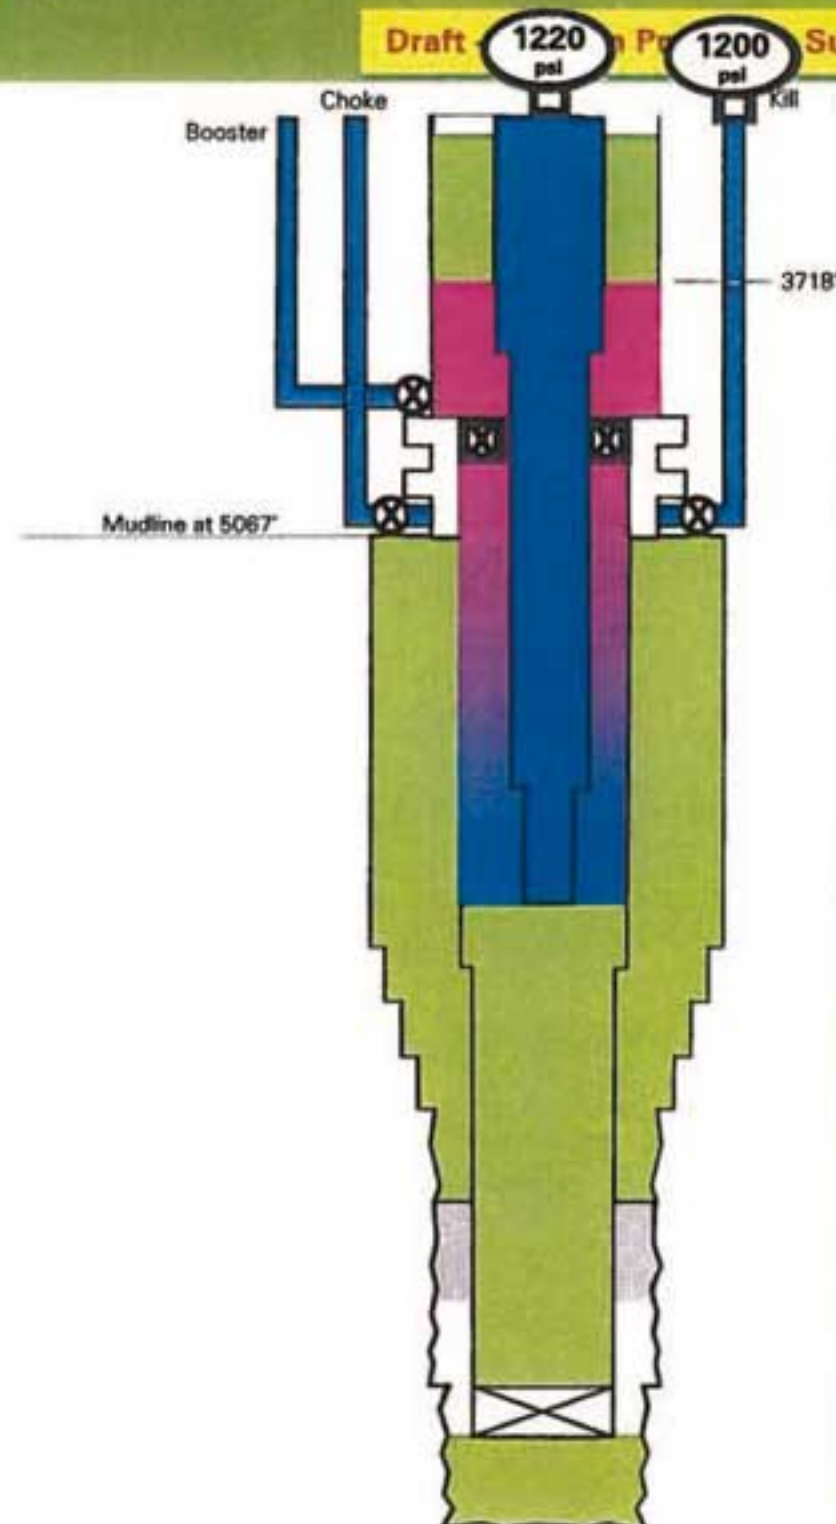
- Bleed drill pipe pressure from 2325 psi to 1220 psi to equalize with kill line

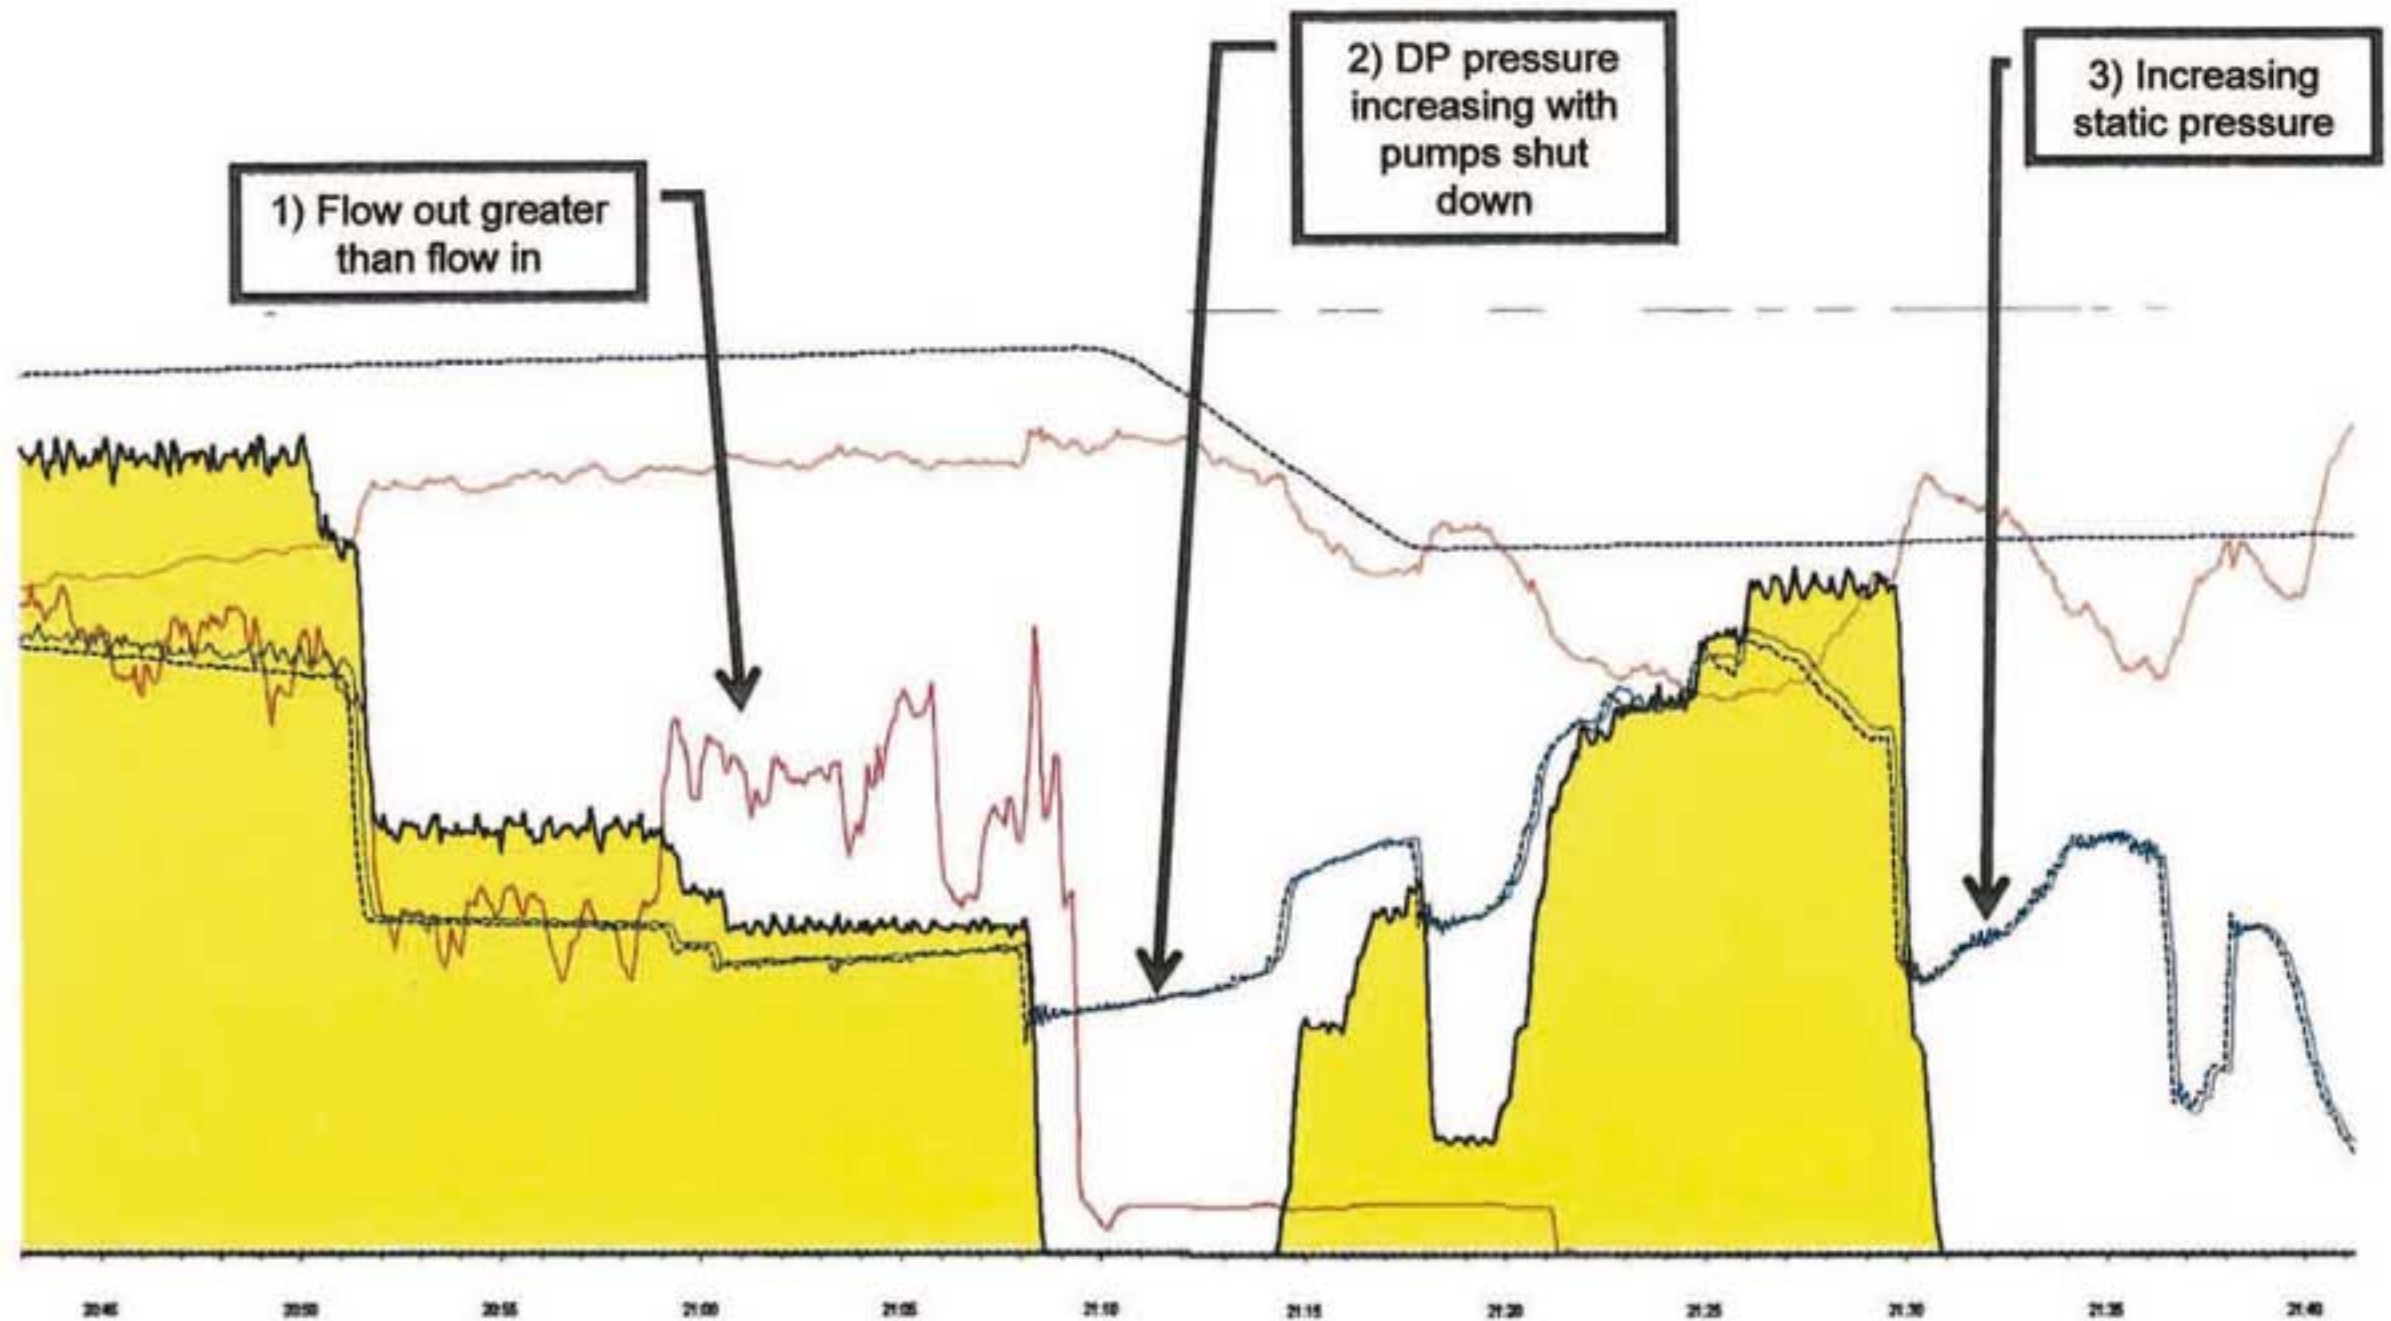
Three Flow Indicators

- At 21:08 – pump shutdown as spacer observed at surface. Sheen test required.
 - Flow-out should be zero, but real-time data indicates well flowing after pump shut off
 - Drillpipe pressure increased from 1017 psi to 1263 psi over 5.5 minute period of sheen test

- Sheen test passed and approval granted to discharge overboard
- At 21:14, pumping resumed to continue displacement to seawater
- At 21:31, problem observed (e.g. mud returns, abnormal pressures)
 - Pump abruptly shutdown
 - Drillpipe pressure at time of shutdown was 1240 psi. Increased to 1750 psi over next 6 minutes.
 - Flow-out data not available due to fluids being discharged directly overboard (bypasses flowmeter)

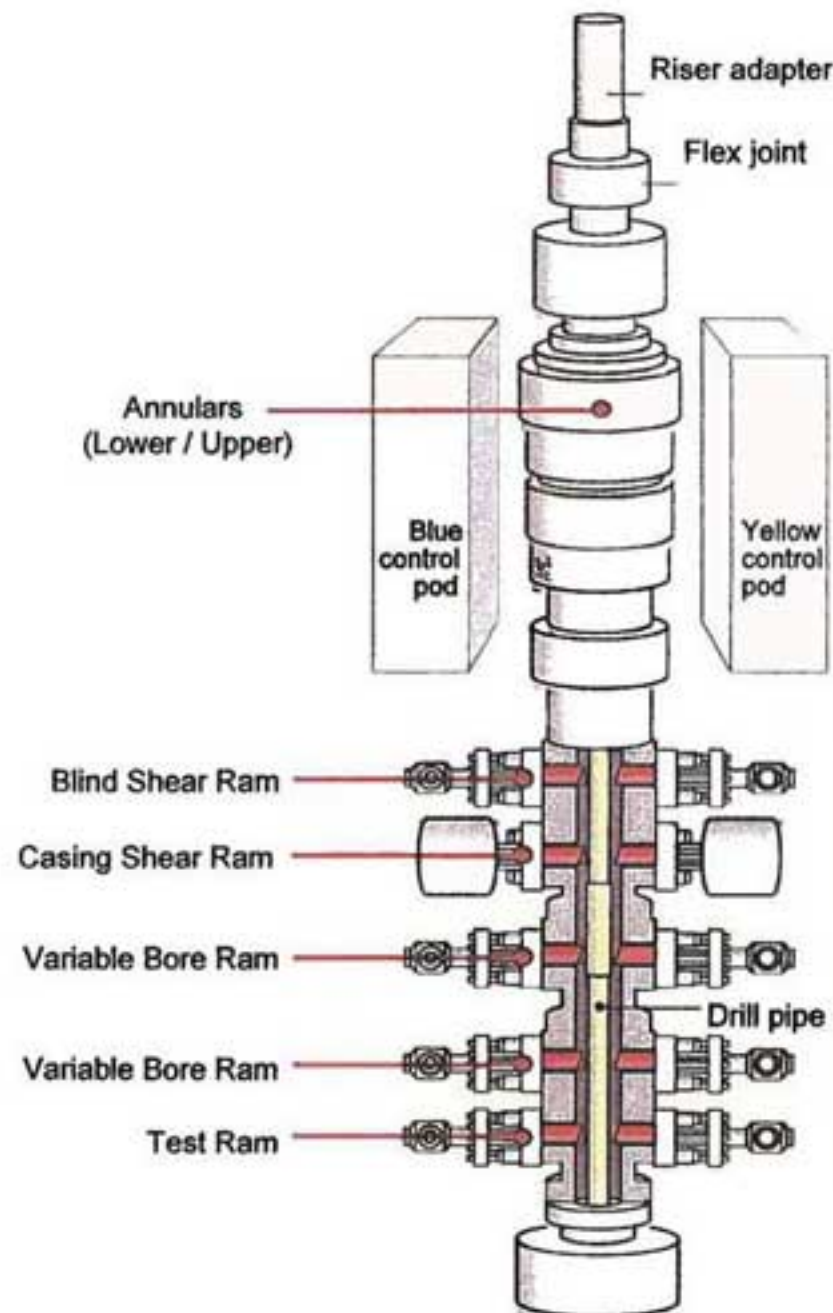
BOP Function Description

- Post the explosion, numerous ROV hot stab interventions were conducted in an attempt to activate
 - Blind Shear rams
 - Variable Pipe rams
 - LMRP Disconnect (Auto shear cut in attempt to activate blind shear rams)
- ROV survey found a number of hydraulic leaks on the system
- ROV identified hydraulic system errors such that test rams were being activated instead of lower variable rams
- ROV identified undocumented modifications to the hydraulic control system; the extent of these modifications is unknown at this time
- Non-destructive examination using ultra-sonics and gamma source were conducted to try and detect position of rams and locks
 - There are indications that the BOP blind shear and variable rams have moved and may be in the locked position, final determination may be possible with the recovery of the BOP

- **Maintenance**
 - Were the BOP and control system properly maintained?
- **Testing**
 - Was the BOP properly tested within regulation; were the primary emergency systems EDS, AMF, Autoshear and ROV Hot Stabs tested regularly?
- **Modifications**
 - Are there as built diagrams of all modifications; is there a record of acceptance testing prior to running the BOP?
 - Did modifications conducted over life of BOP impact functionality?
- **Leaks**
 - Did hydraulic leaks found during ROV interventions and previously noted in Rig log impact functionality?
