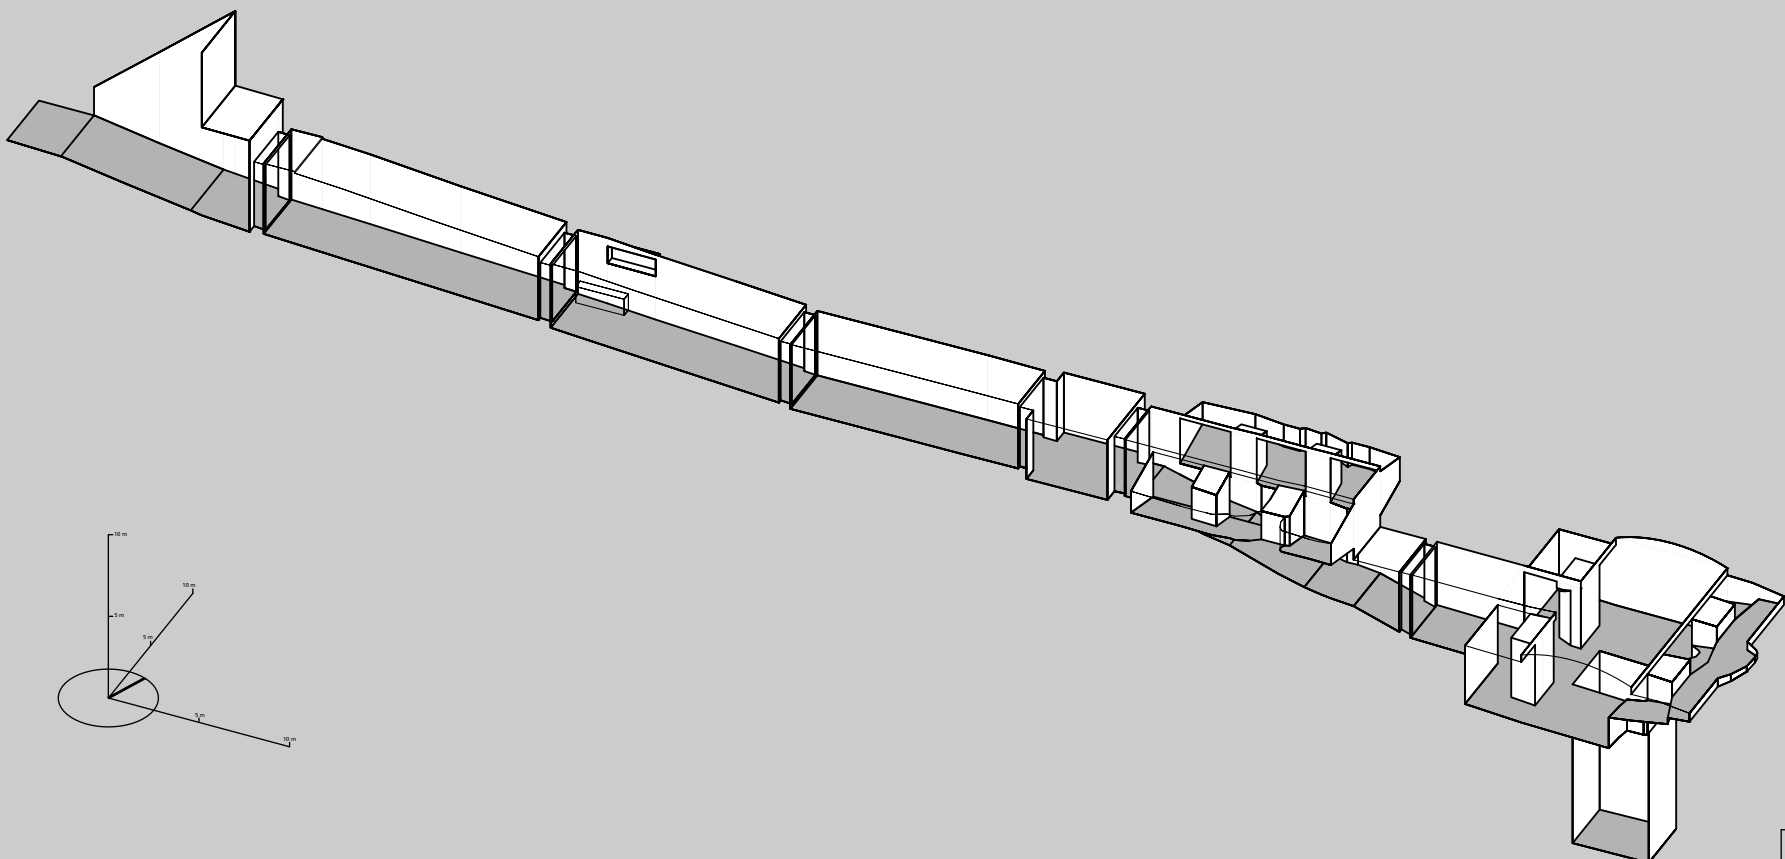
NOTES  
1 Socket for wooden beam that supported the fractured section of the overhang. The beam and the section have fallen away.
